Access Compliance Report

Public Rights-of-Way

(Curb Ramps)

Intersection ID: 13806	Main Street: S_TRYON_ST	Cross Street: WEST_BV	Location: W
ADA ID: D3C5F34CB0E2	Ramp Type: Perp	Initial Pass/Fail: Fail	Overall Compliance: No
Severity Score: 35			
Codes/Mitigation Info/Possible Solution		Field Measurements/Component Compliance

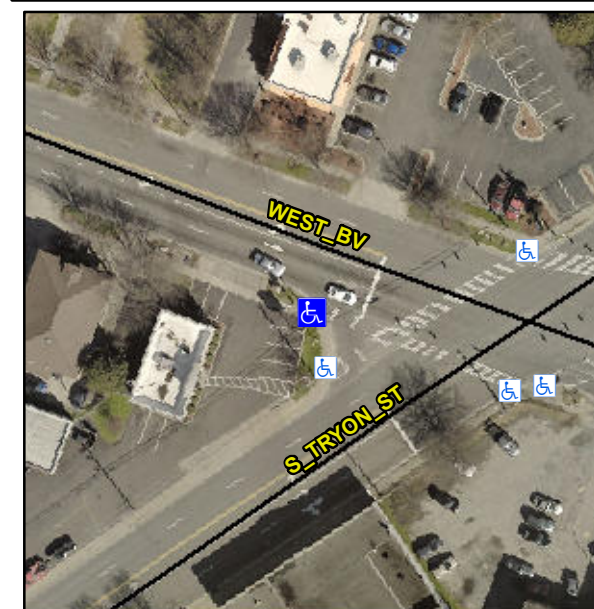
Not Found, R304.5.1, R304.2.2, R304.5.3

Compliance	Description	Data	Compliance	Description	Data
N/A	Ramp Length (in)	74.0	No	Ramp Slope (%)	12.7
No	Ramp Width (in)	43.0	No	Ramp XSlope (%)	4.2
N/A	Flare Type LT	N/A	N/A	Flare Type RT	N/A
N/A	Flare Slope LT (%)	N/A	N/A	Flare Slope RT (%)	N/A
N/A	Flare Traversable LT?	N/A	N/A	Flare Traversable RT?	N/A
N/A	Landing Length (in)	N/A	N/A	DWS Provided?	N/A
N/A	Landing Width (in)	N/A	N/A	DWS Contrast?	N/A
N/A	Landing Slope (%)	N/A	N/A	DWS Length (in)	N/A
N/A	Landing X Slope (%)	N/A	N/A	DWS Full Width?	N/A
N/A	Landing Curb? (Y/N)	N/A	N/A	DWS Offset (in)	N/A
N/A	Shared Landing?	N/A			
N/A	Gutter Ponding?	N/A	N/A	Gutter Slope (%)	N/A
N/A	Gutter Lip Ht (in)	N/A	N/A	Gutter X Slope (%)	N/A
N/A	Painted X Walk1?	Yes	N/A	Painted X Walk2?	N/A
	X Walk 1 Direction	To SE		X Walk 2 Direction	N/A
N/A	X Walk 1 Width (in)	70.0	N/A	X Walk 2 Width (in)	N/A
	X Walk 1 Slope (%)	3.5		X Walk 2 Slope (%)	N/A
	X Walk 1 X Slope (%)	4.1		X Walk 2 X Slope (%)	N/A

N/A	Ramp inside XWalk1?	Yes	N/A	Ramp inside XWalk2?	N/A
	Road Slope (%)	N/A	N/A	Clear Space?	N/A
	Road X Slope (%)	N/A	N/A	Clear Space to XWalk (in)	N/A
N/A	Any Obstructions?	N/A	N/A	Storm Grate/Utility Hazard?	N/A
	Obstruction Type			Storm Grate/Utility Type	
		N/A			N/A
		Yes		Surface Condition? (G/P)	Good

Possible Solutions:

Remove & Replace Entire Ramp.
