Access Compliance Report

Public Rights-of-Way

(Curb Ramps)

Intersection ID: 20138	Main Street: ARBOR_WY	Cross Street: STEDWICK_PL	Location: E
ADA ID: D3CBFDA03E80	Ramp Type: BlendTrans1	Initial Pass/Fail: Fail	Overall Compliance: No
Severity Score: 21.25			
Codes/Mitigation Info/Possible Solution		Field Measurements/Component Compliance

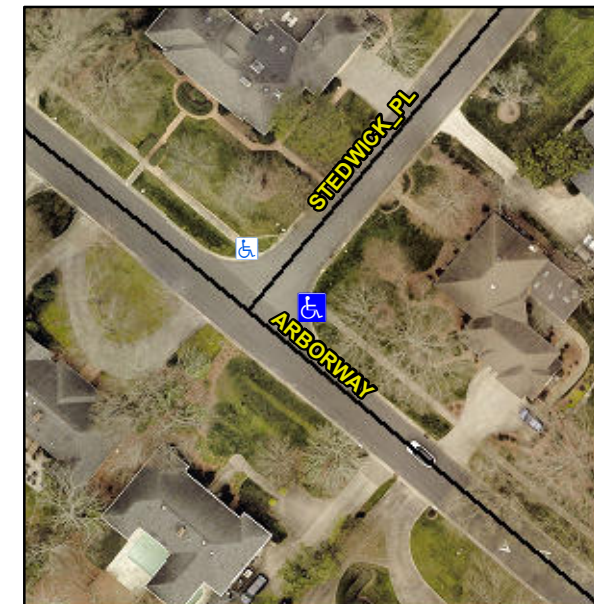
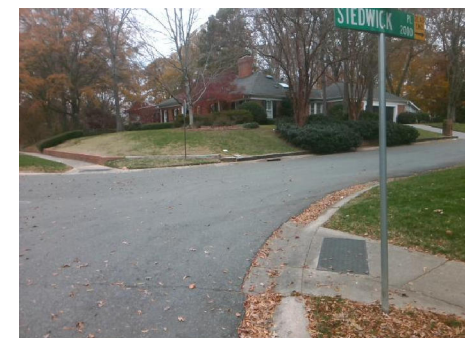
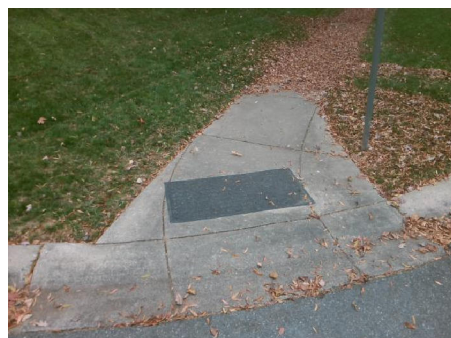
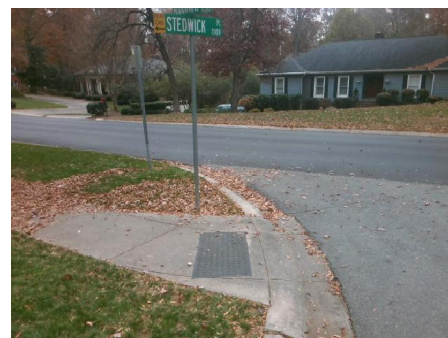
Not Found, R304.5.1, R304.5.3

Compliance	Description	Data	Compliance	Description	Data
N/A	Ramp Length (in)	47.0	Yes	BlendTrans Slope (%)	0.6
No	Ramp Width (in)	47.0	No	BlendTrans XSlope (%)	6.6
N/A	Flare Type LT	N/A	N/A	Flare Type RT	N/A
N/A	Flare Slope LT (%)	N/A	N/A	Flare Slope RT (%)	N/A
N/A	Flare Traversable LT?	N/A	N/A	Flare Traversable RT?	N/A
N/A	Landing Length (in)	N/A	N/A	DWS Provided?	N/A
N/A	Landing Width (in)	N/A	N/A	DWS Contrast?	N/A
N/A	Landing Slope (%)	N/A	N/A	DWS Length (in)	N/A
N/A	Landing X Slope (%)	N/A	N/A	DWS Full Width?	N/A
N/A	Landing Curb? (Y/N)	N/A	N/A	DWS Offset (in)	N/A
N/A	Shared Landing?	N/A			
N/A	Gutter Ponding?	N/A	N/A	Gutter Slope (%)	N/A
N/A	Gutter Lip Ht (in)	N/A	N/A	Gutter X Slope (%)	N/A
N/A	Painted X Walk1?	No	N/A	Painted X Walk2?	No
	X Walk 1 Direction	To NW		X Walk 2 Direction	To SW
	X Walk 1 Width (in)	N/A		X Walk 2 Width (in)	N/A
	X Walk 1 Slope (%)	5.8		X Walk 2 Slope (%)	4.1
	X Walk 1 X Slope (%)	2.2		X Walk 2 X Slope (%)	5.5

N/A	Ramp inside XWalk1?	N/A	N/A	Ramp inside XWalk2?	N/A
	Road Slope (%)	3.8		Clear Space?	N/A
	Road X Slope (%)	5.4	N/A	Clear Space to XWalk (in)	N/A
N/A	Any Obstructions?	N/A	N/A	Storm Grate/Utility Hazard?	N/A
	Obstruction Type			Storm Grate/Utility Type	
		N/A			N/A
			Yes	Surface Condition? (G/P)	Good
			No	Curb Slope (%)	16.7

Possible Solutions:

Remove & Replace Curb Ramp With Two New Directional Ramps or Equivalent.
