# Access Compliance Report

## Public Rights-of-Way

| Intersection ID: 7131 | Main Street: N_TRYON_ST | Cross Street: ORCHARD_TRACE_LN | Location: NW |
| ADA ID: D3F3D38568D6 | Ramp Type: Directional1 | Initial Pass/Fail: Pass | Overall Compliance: No |

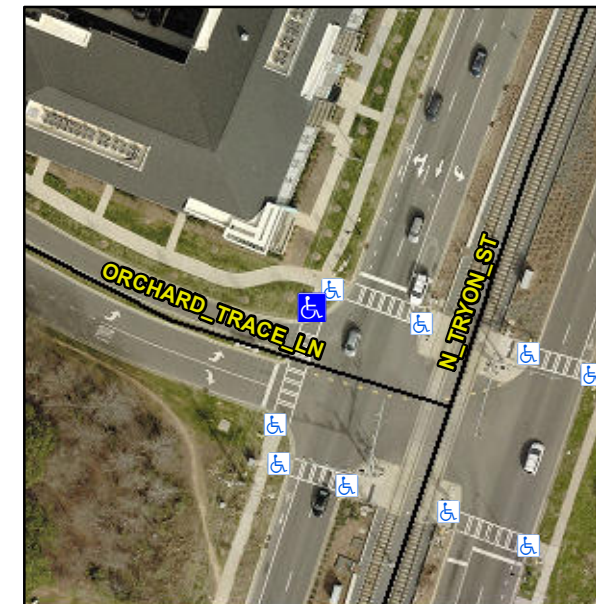
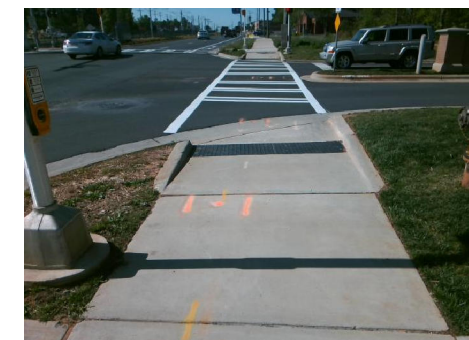
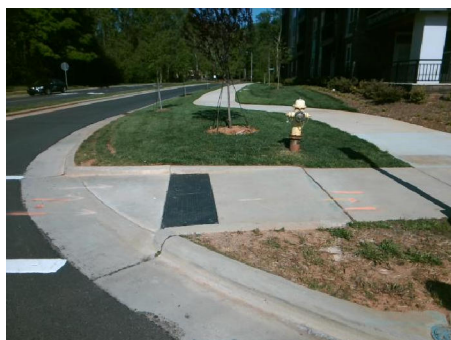
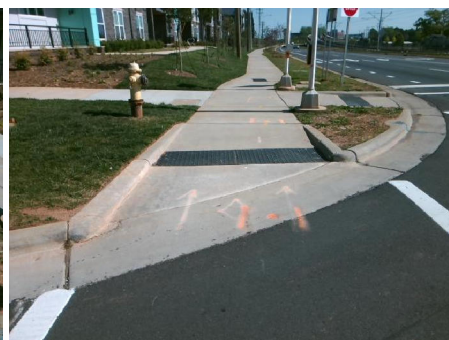
| Severity Score: 0.25 | | | |

**R304.5.3, R304.2.2-Perp, R304.3.2-Para**

| Compliance | Description | Data | Compliance | Description | Data |
|---|---|---|---|---|---|
| No | Ramp XSlope (%) | 2.5 | | | |
| No | Landing Slope (%) | 2.1 | Yes | DWS Length (in) | 24.0 |

**Remove & Replace Entire Ramp.**

Total Cost: \$ 1600.00
