# Access Compliance Report

## Public Rights-of-Way

Intersection ID: 45096	Main Street: E_9TH_ST	Cross Street: N_DAVIDSON_ST	Location: SW
ADA ID: D3F43D0CD846	Ramp Type: MedianPerp	Initial Pass/Fail: Fail	Overall Compliance: No
		Severity Score: 25

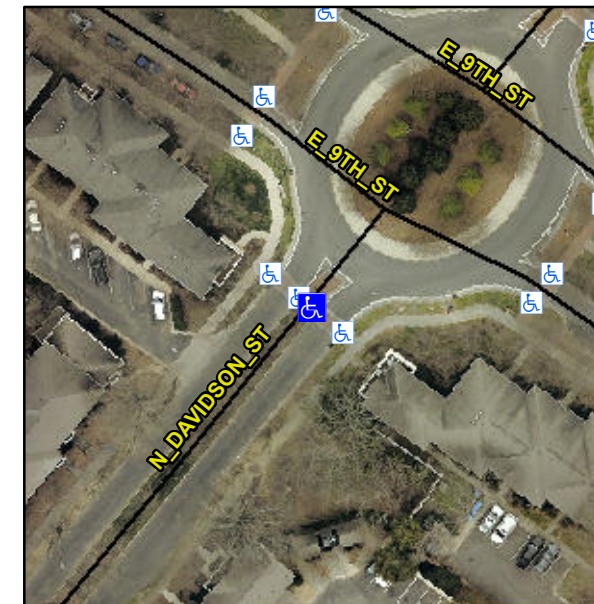
**Not Found, R304.2.2, R304.5.3**

Compliance	Description	Data	Compliance	Description	Data
N/A	Ramp Length (in)	55.0	No	Ramp Slope (%)	10.7
Yes	Ramp Width (in)	71.0	No	Ramp XSlope (%)	6.0
N/A	Flare Type LT	N/A	N/A	Flare Type RT	N/A
N/A	Flare Slope LT (%)	N/A	N/A	Flare Slope RT (%)	N/A
N/A	Flare Traversable LT?	N/A	N/A	Flare Traversable RT?	N/A
N/A	Landing Length (in)	N/A	N/A	DWS Provided?	N/A
N/A	Landing Width (in)	N/A	N/A	DWS Contrast?	N/A
N/A	Landing Slope (%)	N/A	N/A	DWS Length (in)	N/A
N/A	Landing X Slope (%)	N/A	N/A	DWS Full Width?	N/A
N/A	Landing Curb? (Y/N)	N/A	N/A	DWS Offset (in)	N/A
N/A	Shared Landing?	N/A			
N/A	Gutter Ponding?	N/A	N/A	Gutter Slope (%)	N/A
N/A	Gutter Lip Ht (in)	N/A	N/A	Gutter X Slope (%)	N/A
N/A	Painted X Walk1?	Yes	N/A	Painted X Walk2?	N/A
	X Walk 1 Direction	To SE		X Walk 2 Direction	N/A
N/A	X Walk 1 Width (in)	82.0	N/A	X Walk 2 Width (in)	N/A
	X Walk 1 Slope (%)	2.8		X Walk 2 Slope (%)	N/A
	X Walk 1 X Slope (%)	7.5		X Walk 2 X Slope (%)	N/A

**Remove & Replace Entire Ramp.**

Total Cost: \$ 1650.00
