Access Compliance Report

Public Rights-of-Way

(Curb Ramps)

Intersection ID: 15796	Main Street: SNOW_LN	Cross Street: IDLEWILD_RD_NORTH	Location: SE
ADA ID: D3F4ECD3112C	Ramp Type: PerpDiag	Initial Pass/Fail: Fail	Overall Compliance: No
Severity Score: 22.5			
Codes/Mitigation Info/Possible Solution		Field Measurements/Component Compliance

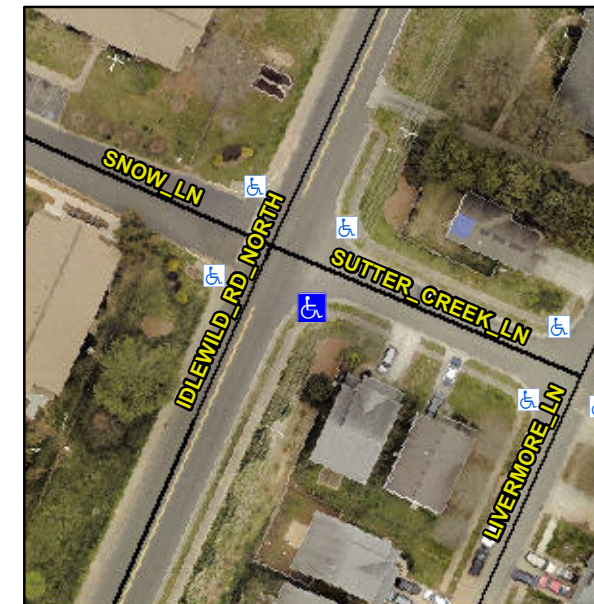
Not Found, R304.5.1, R304.2.2, R304.5.3

Compliance	Description	Data	Compliance	Description	Data
N/A	Ramp Length (in)	52.0	No	Ramp Slope (%)	9.2
No	Ramp Width (in)	38.0	No	Ramp XSlope (%)	3.0
N/A	Flare Type LT	N/A	N/A	Flare Type RT	N/A
N/A	Flare Slope LT (%)	N/A	N/A	Flare Slope RT (%)	N/A
N/A	Flare Traversable LT?	N/A	N/A	Flare Traversable RT?	N/A
N/A	Landing Length (in)	N/A	N/A	DWS Provided?	N/A
N/A	Landing Width (in)	N/A	N/A	DWS Contrast?	N/A
N/A	Landing Slope (%)	N/A	N/A	DWS Length (in)	N/A
N/A	Landing X Slope (%)	N/A	N/A	DWS Full Width?	N/A
N/A	Landing Curb? (Y/N)	N/A	N/A	DWS Offset (in)	N/A
N/A	Shared Landing?	N/A			
N/A	Gutter Ponding?	N/A	N/A	Gutter Slope (%)	N/A
N/A	Gutter Lip Ht (in)	N/A	N/A	Gutter X Slope (%)	N/A
N/A	Painted X Walk1?	No	N/A	Painted X Walk2?	No
	X Walk 1 Direction	To NE		X Walk 2 Direction	To NW
N/A	X Walk 1 Width (in)	N/A	N/A	X Walk 2 Width (in)	N/A
	X Walk 1 Slope (%)	0.8		X Walk 2 Slope (%)	1.8
	X Walk 1 X Slope (%)	1.8		X Walk 2 X Slope (%)	0.8

N/A	Ramp inside XWalk1?	N/A	N/A	Ramp inside XWalk2?	N/A
	Road Slope (%)	0.6	N/A	Clear Space?	N/A
	Road X Slope (%)	0.3	N/A	Clear Space to XWalk (in)	N/A
N/A	Any Obstructions?	N/A	N/A	Storm Grate/Utility Hazard?	N/A
	Obstruction Type			Storm Grate/Utility Type	
		N/A			N/A
			Yes	Surface Condition? (G/P)	Good

Possible Solutions:

Remove & Replace Curb Ramp With Two New Directional Ramps or Equivalent.
