Access Compliance Report

Public Rights-of-Way (Curb Ramps)

Intersection ID: 10036062	Main Street: RIVERGATE_PY	Cross Street: N/A	Location: SE
ADA ID: D3FEDAFA038F	Ramp Type: Perp	Initial Pass/Fail: Pass	Overall Compliance: No
		Severity Score: 2.5

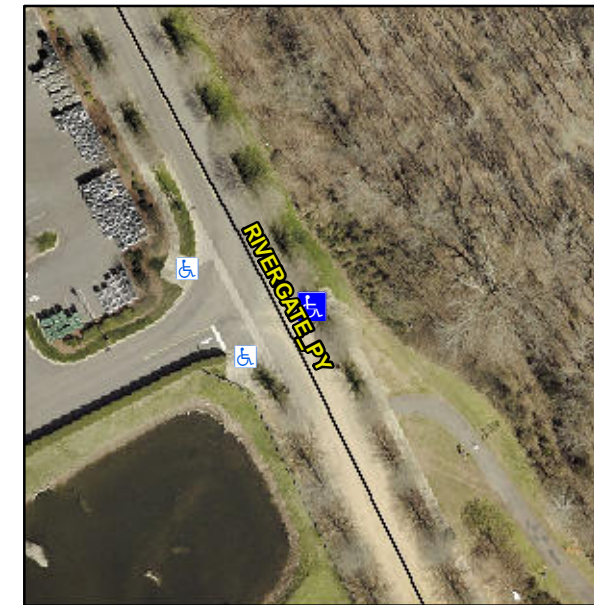
Compliance	Description	Data	Compliance	Description	Data
N/A	Ramp Length (in)	95.0	Yes	Ramp Slope (%)	6.7
Yes	Ramp Width (in)	57.5	Yes	Ramp XSlope (%)	1.2
N/A	Flare Type LT	Sloped	N/A	Flare Type RT	N/A
N/A	Flare Slope LT (%)	8.9	Yes	Flare Slope RT (%)	5.0
N/A	Flare Traversable LT?	Yes	N/A	Flare Traversable RT?	Yes
Yes	Landing Length (in)	71.0	Yes	DWS Provided?	Yes
Yes	Landing Width (in)	57.0	Yes	DWS Contrast?	Yes
No	Landing Slope (%)	4.2	Yes	DWS Length (in)	24.0
Yes	Landing X Slope (%)	0.6	No	DWS Full Width?	No
N/A	Landing Curb? (Y/N)	No	No	DWS Offset (in)	5.0
N/A	Shared Landing?	No			
Yes	Gutter Ponding?	No	Yes	Gutter Slope (%)	2.1
Yes	Gutter Lip Ht (in)	0.0	Yes	Gutter X Slope (%)	0.7
N/A	Painted X Walk1?	No	N/A	Painted X Walk2?	N/A
	X Walk 1 Direction	To SW		X Walk 2 Direction	N/A
N/A	X Walk 1 Width (in)	N/A	N/A	X Walk 2 Width (in)	N/A
	X Walk 1 Slope (%)	2.7		X Walk 2 Slope (%)	N/A
	X Walk 1 X Slope (%)	1.3		X Walk 2 X Slope (%)	N/A

N/A	Ramp inside XWalk1?	N/A	N/A	Ramp inside XWalk2?	N/A
	Road Slope (%)	N/A	N/A	Clear Space?	Yes
	Road X Slope (%)	N/A	N/A	Clear Space to XWalk (in)	N/A
Yes	Any Obstructions?	No	Yes	Storm Grate/Utility Hazard?	No
	Obstruction Type			Storm Grate/Utility Type	
		N/A			N/A
			Yes	Surface Condition? (G/P)	Good

Remove & Replace Entire Ramp.
