# Access Compliance Report

## Public Rights-of-Way

| Intersection ID: 21096 | Main Street: FOLGER_DR | Cross Street: OWENBY_CT | Location: W |
| ADA ID: D40568295EAA | Ramp Type: ParaDiag | Initial Pass/Fail: Pass | Overall Compliance: No |

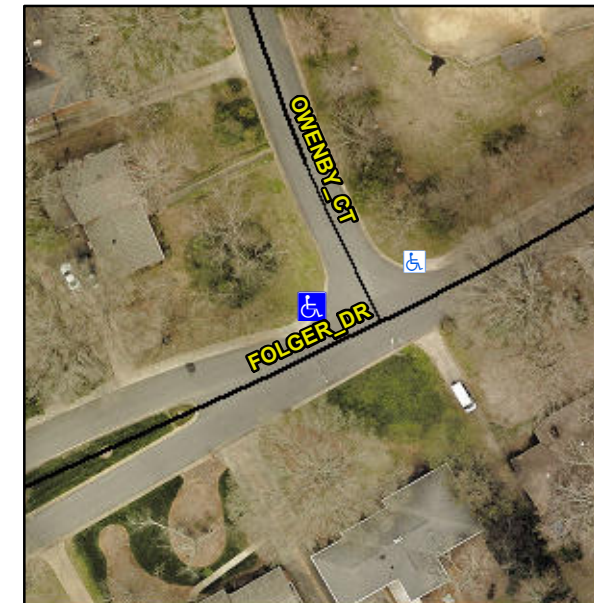
**RT RP < 5%**

**R304.5.3, R304.2.2-Perp, R304.3.2-Para**

| Compliance | Description | Data | Compliance | Description | Data |
|---|---|---|---|---|---|
| Yes | Ramp XSlope LT (%) | 0.6 | No | Ramp XSlope RT (%) | 2.2 |
| No | Landing Slope (%) | 4.7 | Yes | DWS Length (in) | 25.0 |

**Remove & Replace Landing.**  
**Remove & Replace Sidewalk.**
