Access Compliance Report

Public Rights-of-Way

(Curb Ramps)

Intersection ID: 48857	Main Street: FENCELINE_DR	Cross Street: GREENFINCH_DR	Location: NE
ADA ID: D4069FE514BA	Ramp Type: PerpDiag	Initial Pass/Fail: Fail	Overall Compliance: No
Severity Score: 12.5			
Codes/Mitigation Info/Possible Solution		Field Measurements/Component Compliance

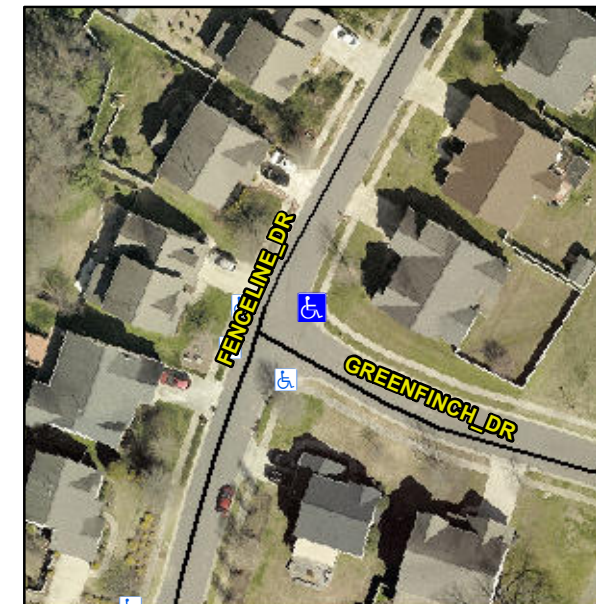
Compliance	Description	Data	Compliance	Description	Data
N/A	Ramp Length (in)	47.0	No	Ramp Slope (%)	9.5
Yes	Ramp Width (in)	48.0	Yes	Ramp XSlope (%)	1.3
N/A	Flare Type LT	N/A	N/A	Flare Type RT	N/A
N/A	Flare Slope LT (%)	N/A	N/A	Flare Slope RT (%)	N/A
N/A	Flare Traversable LT?	N/A	N/A	Flare Traversable RT?	N/A
N/A	Landing Length (in)	N/A	N/A	DWS Provided?	N/A
N/A	Landing Width (in)	N/A	N/A	DWS Contrast?	N/A
N/A	Landing Slope (%)	N/A	N/A	DWS Length (in)	N/A
N/A	Landing X Slope (%)	N/A	N/A	DWS Full Width?	N/A
N/A	Landing Curb? (Y/N)	N/A	N/A	DWS Offset (in)	N/A
N/A	Shared Landing?	N/A			
N/A	Gutter Ponding?	N/A	N/A	Gutter Slope (%)	N/A
N/A	Gutter Lip Ht (in)	N/A	N/A	Gutter X Slope (%)	N/A
N/A	Painted X Walk1?	No	N/A	Painted X Walk2?	No
	X Walk 1 Direction	To NW		X Walk 2 Direction	To SW
N/A	X Walk 1 Width (in)	N/A	N/A	X Walk 2 Width (in)	N/A
	X Walk 1 Slope (%)	0.6		X Walk 2 Slope (%)	0.0
	X Walk 1 X Slope (%)	0.7		X Walk 2 X Slope (%)	0.9

N/A	Ramp inside XWalk1?	N/A	N/A	Ramp inside XWalk2?	N/A
	Road Slope (%)	0.1	N/A	Clear Space?	N/A
	Road X Slope (%)	1.8	N/A	Clear Space to XWalk (in)	N/A
N/A	Any Obstructions?	N/A	N/A	Storm Grate/Utility Hazard?	N/A
	Obstruction Type			Storm Grate/Utility Type	
		N/A			N/A
		Yes		Surface Condition? (G/P)	Good

Possible Solutions:

Remove & Replace Curb Ramp With Two New Directional Ramps or Equivalent.

PROW/ADA:

R304.2.2
