# Access Compliance Report

## Public Rights-of-Way

### (Curb Ramps)

| Intersection ID: 44689 | Main Street: SHANON_DARBY_LN | Cross Street: GENTLE_STREAM_LN | Location: S |

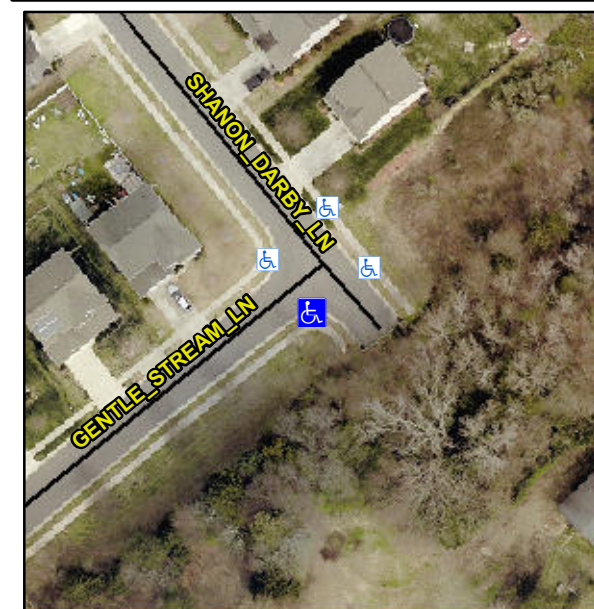
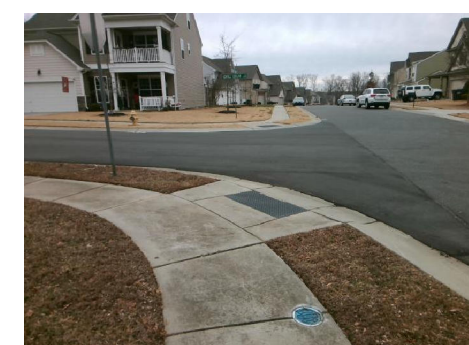
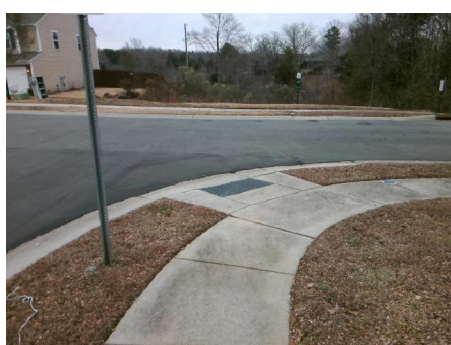
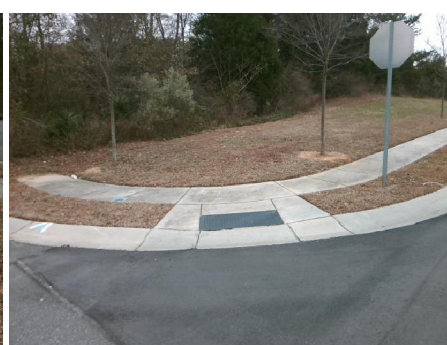
**Not Found, R304.5.1, R304.5.3**

| Compliance | Description | Data | Compliance | Description | Data |
|---|---|---|---|---|---|
| N/A | Ramp Length (in) | 48.0 | Yes | Ramp Slope (%) | 5.1 |
| No | Ramp Width (in) | 47.5 | No | Ramp XSlope (%) | 8.9 |

**Remove & Replace Curb Ramp With Two New Directional Ramps or Equivalent.**
