Access Compliance Report

Public Rights-of-Way

(Curb Ramps)

Intersection ID: 6255	Main Street: HOOVER_DR	Cross Street: NEVIN_RD	Location: NW
ADA ID: D4168165A665	Ramp Type: BlendTrans1	Initial Pass/Fail: Fail	Overall Compliance: No
Severity Score: 1.25			
Codes/Mitigation Info/Possible Solution		Field Measurements/Component Compliance

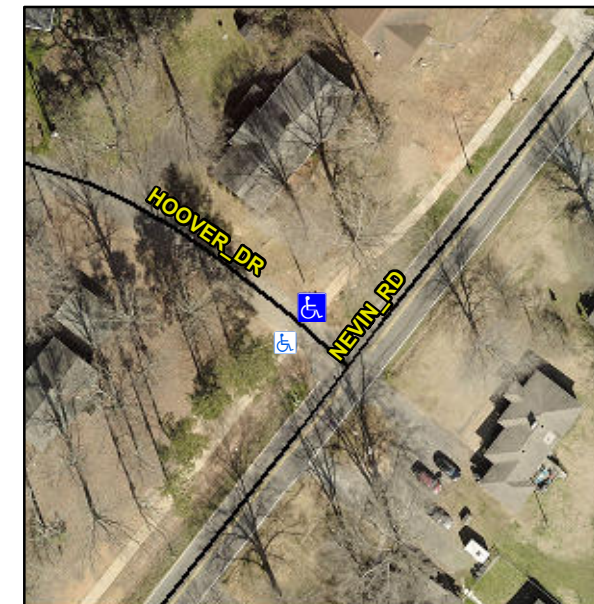
DWS OS MEASURED TO APSHALT, RP SL < 5%, FAILED INITIAL VALIDATION

Compliance	Description	Data	Compliance	Description	Data
N/A	Ramp Length (in)	80.0	Yes	BlendTrans Slope (%)	0.2
Yes	Ramp Width (in)	72.0	No	BlendTrans XSlope (%)	3.0
N/A	Flare Type LT	N/A	N/A	Flare Type RT	N/A
N/A	Flare Slope LT (%)	N/A	N/A	Flare Slope RT (%)	N/A
N/A	Flare Traversable LT?	N/A	N/A	Flare Traversable RT?	N/A
N/A	Landing Length (in)	N/A	N/A	DWS Provided?	N/A
N/A	Landing Width (in)	N/A	N/A	DWS Contrast?	N/A
N/A	Landing Slope (%)	N/A	N/A	DWS Length (in)	N/A
N/A	Landing X Slope (%)	N/A	N/A	DWS Full Width?	N/A
N/A	Landing Curb? (Y/N)	N/A	N/A	DWS Offset (in)	N/A
N/A	Shared Landing?	N/A			
N/A	Gutter Ponding?	N/A	N/A	Gutter Slope (%)	N/A
N/A	Gutter Lip Ht (in)	N/A	N/A	Gutter X Slope (%)	N/A
N/A	Painted X Walk1?	No	N/A	Painted X Walk2?	N/A
	X Walk 1 Direction	To W		X Walk 2 Direction	N/A
	X Walk 1 Width (in)	N/A		X Walk 2 Width (in)	N/A
	X Walk 1 Slope (%)	0.5		X Walk 2 Slope (%)	N/A
	X Walk 1 X Slope (%)	2.1		X Walk 2 X Slope (%)	N/A

N/A	Ramp inside XWalk1?	N/A	N/A	Ramp inside XWalk2?	N/A
	Road Slope (%)	2.1		Clear Space?	N/A
	Road X Slope (%)	0.5	N/A	Clear Space to XWalk (in)	N/A
N/A	Any Obstructions?	N/A	N/A	Storm Grate/Utility Hazard?	N/A
	Obstruction Type			Storm Grate/Utility Type	
		N/A			N/A
			Yes	Surface Condition? (G/P)	Good
			N/A	Curb Slope (%)	N/A

Remove & Replace Curb Ramp With Two New Directional Ramps or Equivalent.
