Access Compliance Report

Public Rights-of-Way

(Curb Ramps)

Intersection ID: 3274	Main Street: MALLARD_GREEN_PL	Cross Street: SHELLY_PINES_DR	Location: W
ADA ID: D42261809782	Ramp Type: Perp	Initial Pass/Fail: Fail	Overall Compliance: No
Severity Score: 22.5			
Codes/Mitigation Info/Possible Solution		Field Measurements/Component Compliance

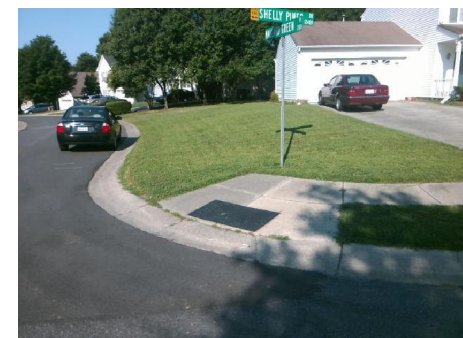
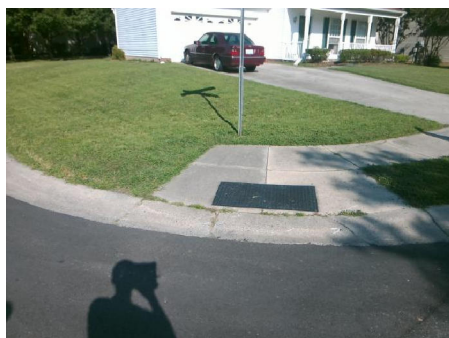
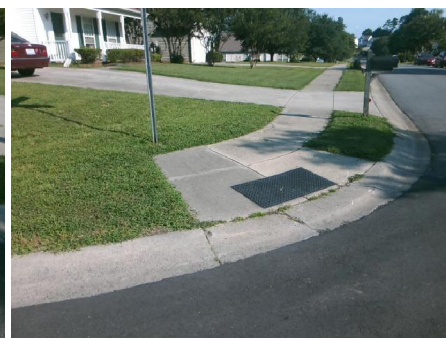
Not Found, R304.5.1, R304.2.2, R304.5.3

Compliance	Description	Data	Compliance	Description	Data
N/A	Ramp Length (in)	47.5	No	Ramp Slope (%)	9.0
No	Ramp Width (in)	43.0	No	Ramp XSlope (%)	3.5
N/A	Flare Type LT	N/A	N/A	Flare Type RT	N/A
N/A	Flare Slope LT (%)	N/A	N/A	Flare Slope RT (%)	N/A
N/A	Flare Traversable LT?	N/A	N/A	Flare Traversable RT?	N/A
N/A	Landing Length (in)	N/A	N/A	DWS Provided?	N/A
N/A	Landing Width (in)	N/A	N/A	DWS Contrast?	N/A
N/A	Landing Slope (%)	N/A	N/A	DWS Length (in)	N/A
N/A	Landing X Slope (%)	N/A	N/A	DWS Full Width?	N/A
N/A	Landing Curb? (Y/N)	N/A	N/A	DWS Offset (in)	N/A
N/A	Shared Landing?	N/A			
N/A	Gutter Ponding?	N/A	N/A	Gutter Slope (%)	N/A
N/A	Gutter Lip Ht (in)	N/A	N/A	Gutter X Slope (%)	N/A
N/A	Painted X Walk1?	No	N/A	Painted X Walk2?	N/A
	X Walk 1 Direction	To SE		X Walk 2 Direction	N/A
N/A	X Walk 1 Width (in)	N/A	N/A	X Walk 2 Width (in)	N/A
	X Walk 1 Slope (%)	3.8		X Walk 2 Slope (%)	N/A
	X Walk 1 X Slope (%)	4.0		X Walk 2 X Slope (%)	N/A

Remove & Replace Entire Ramp.
