Access Compliance Report

Public Rights-of-Way

(Curb Ramps)

Intersection ID: 44757	Main Street: BONNER_BRIDGE_CT	Cross Street: KINGS_PARADE_BV	Location: NW
ADA ID: D427A125254A	Ramp Type: Perp	Initial Pass/Fail: Fail	Overall Compliance: No
		Severity Score: 10

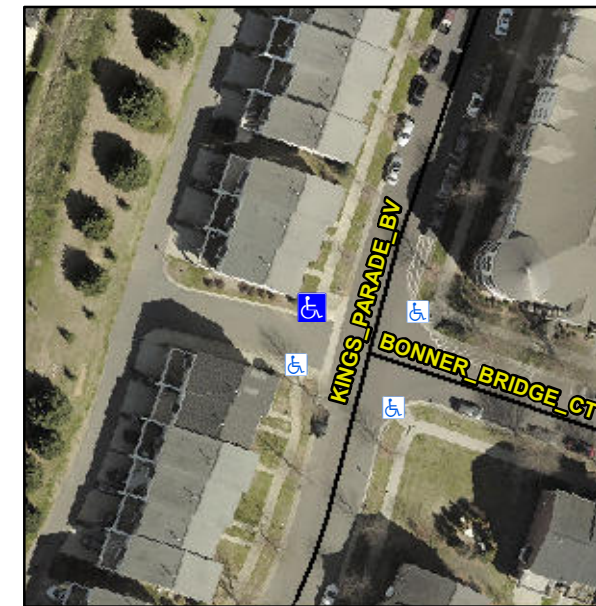
Not Found, R304.5.1, R304.5.3

Compliance	Description	Data	Compliance	Description	Data
N/A	Ramp Length (in)	85.0	Yes	Ramp Slope (%)	5.2
No	Ramp Width (in)	42.0	No	Ramp XSlope (%)	2.8
N/A	Flare Type LT	N/A	N/A	Flare Type RT	N/A
N/A	Flare Slope LT (%)	N/A	N/A	Flare Slope RT (%)	N/A
N/A	Flare Traversable LT?	N/A	N/A	Flare Traversable RT?	N/A
N/A	Landing Length (in)	N/A	N/A	DWS Provided?	N/A
N/A	Landing Width (in)	N/A	N/A	DWS Contrast?	N/A
N/A	Landing Slope (%)	N/A	N/A	DWS Length (in)	N/A
N/A	Landing X Slope (%)	N/A	N/A	DWS Full Width?	N/A
N/A	Landing Curb? (Y/N)	N/A	N/A	DWS Offset (in)	N/A
N/A	Shared Landing?	N/A			
N/A	Gutter Ponding?	N/A	N/A	Gutter Slope (%)	N/A
N/A	Gutter Lip Ht (in)	N/A	N/A	Gutter X Slope (%)	N/A
N/A	Painted X Walk1?	No	N/A	Painted X Walk2?	N/A
	X Walk 1 Direction	To S		X Walk 2 Direction	N/A
N/A	X Walk 1 Width (in)	N/A	N/A	X Walk 2 Width (in)	N/A
	X Walk 1 Slope (%)	2.1		X Walk 2 Slope (%)	N/A
	X Walk 1 X Slope (%)	5.0		X Walk 2 X Slope (%)	N/A

N/A	Ramp inside XWalk1?	N/A	N/A	Ramp inside XWalk2?	N/A
	Road Slope (%)	N/A	N/A	Clear Space?	N/A
	Road X Slope (%)	N/A	N/A	Clear Space to XWalk (in)	N/A
N/A	Any Obstructions?	N/A	N/A	Storm Grate/Utility Hazard?	N/A
	Obstruction Type			Storm Grate/Utility Type	
		N/A			N/A
			Yes	Surface Condition? (G/P)	Good

Remove & Replace Entire Ramp.
