Access Compliance Report

Public Rights-of-Way

(Curb Ramps)

Intersection ID: 11425	Main Street: AVENING_CT	Cross Street: AVENSONG_CROSSING_DR	Location: NW
ADA ID: D43014A2980E	Ramp Type: BlendTrans1	Initial Pass/Fail: Fail	Overall Compliance: No
		Severity Score: 17.5

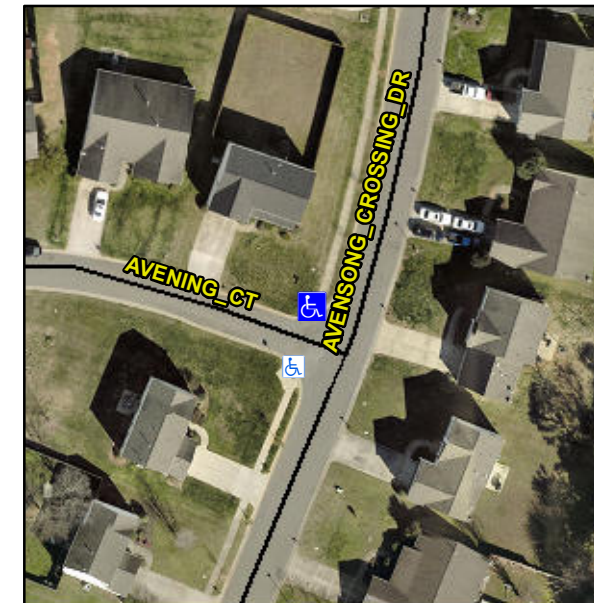
CURB GAP 1.0, NO LT SW

Not Found, R304.5.1

Compliance	Description	Data	Compliance	Description	Data
N/A	Ramp Length (in)	48.0	Yes	BlendTrans Slope (%)	2.3
No	Ramp Width (in)	35.5	Yes	BlendTrans XSlope (%)	2.0
N/A	Flare Type LT	N/A	N/A	Flare Type RT	N/A
N/A	Flare Slope LT (%)	N/A	N/A	Flare Slope RT (%)	N/A
N/A	Flare Traversable LT?	N/A	N/A	Flare Traversable RT?	N/A
N/A	Landing Length (in)	N/A	N/A	DWS Provided?	N/A
N/A	Landing Width (in)	N/A	N/A	DWS Contrast?	N/A
N/A	Landing Slope (%)	N/A	N/A	DWS Length (in)	N/A
N/A	Landing X Slope (%)	N/A	N/A	DWS Full Width?	N/A
N/A	Landing Curb? (Y/N)	N/A	N/A	DWS Offset (in)	N/A
N/A	Shared Landing?	N/A			
N/A	Gutter Ponding?	N/A	N/A	Gutter Slope (%)	N/A
N/A	Gutter Lip Ht (in)	N/A	N/A	Gutter X Slope (%)	N/A
N/A	Painted X Walk1?	No	N/A	Painted X Walk2?	N/A
	X Walk 1 Direction	To S		X Walk 2 Direction	N/A
	X Walk 1 Width (in)	N/A		X Walk 2 Width (in)	N/A
	X Walk 1 Slope (%)	2.5		X Walk 2 Slope (%)	N/A
	X Walk 1 X Slope (%)	4.5		X Walk 2 X Slope (%)	N/A

N/A	Ramp inside XWalk1?	N/A	N/A	Ramp inside XWalk2?	N/A
	Road Slope (%)	4.5		Clear Space?	N/A
	Road X Slope (%)	2.5	N/A	Clear Space to XWalk (in)	N/A
N/A	Any Obstructions?	N/A	N/A	Storm Grate/Utility Hazard?	N/A
	Obstruction Type			Storm Grate/Utility Type	
		N/A			N/A
			Yes	Surface Condition? (G/P)	Good
			No	Curb Slope (%)	17.8

Remove & Replace Curb Ramp With Two New Directional Ramps or Equivalent.
