# Access Compliance Report

## Public Rights-of-Way

### (Curb Ramps)

Intersection ID: 10020667	Main Street: BEACON_VALLEY_ST	Cross Street: N/A	Location: S
ADA ID: D4341109B240	Ramp Type: Perp	Initial Pass/Fail: Fail	Overall Compliance: No
		Severity Score: 12.5

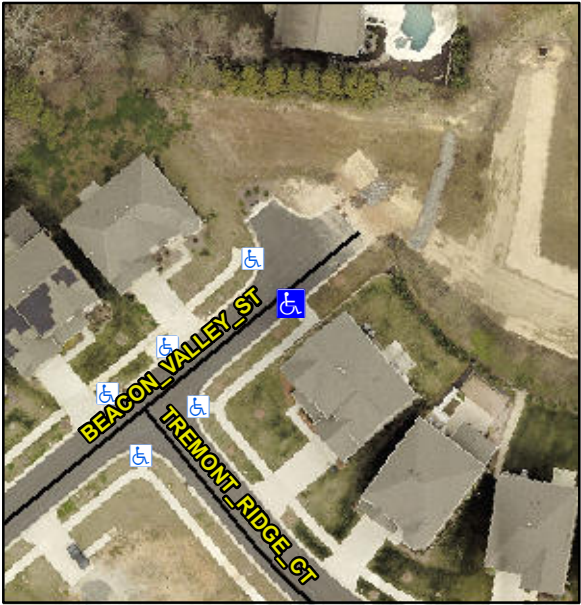
Possible Solutions:		<b>Compliance</b>	<b>Description</b>	<b>Data</b>
	<b>Remove &amp; Replace Entire Ramp.</b>		<b>Yes</b>	Ramp Length (in)	93.0
			<b>No</b>	Ramp Width (in)	48.0
			<b>N/A</b>	Flare Type LT	N/A
			<b>N/A</b>	Flare Slope LT (%)	N/A
			<b>N/A</b>	Flare Traversable LT?	N/A
			<b>N/A</b>	Landing Length (in)	N/A
			<b>N/A</b>	Landing Width (in)	N/A
			<b>N/A</b>	Landing Slope (%)	N/A
			<b>N/A</b>	Landing X Slope (%)	N/A
<p>Surveyor Notes:</p> <p><b>N/A</b></p>			<b>N/A</b>	Landing Curb? (Y/N)	N/A
			<b>N/A</b>	Shared Landing?	N/A
			<b>N/A</b>	Gutter Ponding?	N/A
			<b>N/A</b>	Gutter Lip Ht (in)	N/A
			<b>No</b>	Painted X Walk1?	N/A
			<b>To NW</b>	X Walk 1 Direction	N/A
			<b>N/A</b>	X Walk 1 Width (in)	N/A
			<b>2.7</b>	X Walk 1 Slope (%)	N/A
			<b>6.5</b>	X Walk 1 X Slope (%)	N/A
			<b>N/A</b>	Ramp inside XWalk1?	N/A

<p>PROW/ADA:</p> <p><b>Not Found, R304.5.3</b></p>			<b>N/A</b>	Road Slope (%)	N/A
			<b>N/A</b>	Road X Slope (%)	N/A
			<b>N/A</b>	Any Obstructions?	N/A
				Obstruction Type	N/A
			<b>N/A</b>		N/A
			<b>Yes</b>	Surface Condition? (G/P)	Good
Total Cost:		\$ 1850.00
