Access Compliance Report

Public Rights-of-Way

(Curb Ramps)

| Intersection ID: 24358 | Main Street: CASHEL_CT | Cross Street: PRESCOTT_POND_LN | Location: SW |

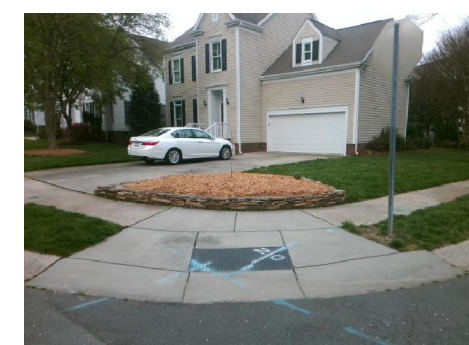
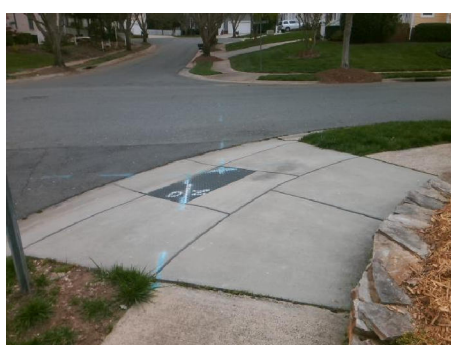
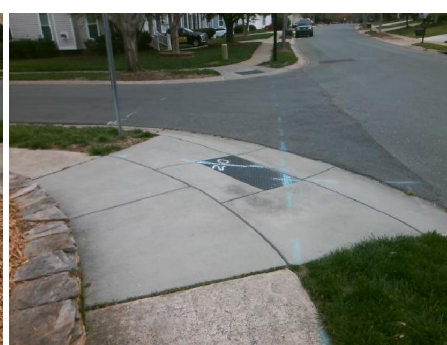
| ADA ID: D4390B1E5924 | Ramp Type: PerpDiag | Initial Pass/Fail: Fail | Overall Compliance: No |

Not Found, R304.5.1, R304.2.2

| Compliance | Description | Data | Compliance | Description | Data |
|---|---|---|---|---|---|
| N/A | Ramp Length (in) | 48.0 | No | Ramp Slope (%) | 13.4 |
| No | Ramp Width (in) | 47.0 | Yes | Ramp XSlope (%) | 1.1 |

Remove & Replace Curb Ramp With Two New Directional Ramps or Equivalent.
