Access Compliance Report

Public Rights-of-Way

(Curb Ramps)

Intersection ID: 6838	Main Street: OLD_PLANK_RD	Cross Street: MARGARET_TURNER_RD	Location: NW
ADA ID: D441C38ECE46	Ramp Type: Perp	Initial Pass/Fail: Fail	Overall Compliance: No
			Severity Score: 26.25

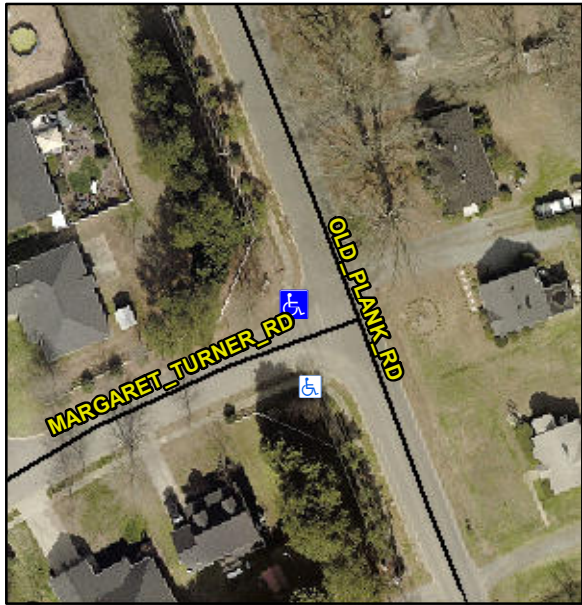
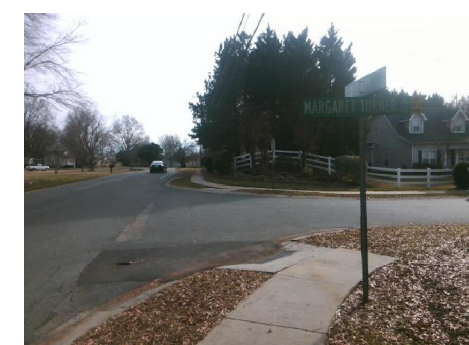
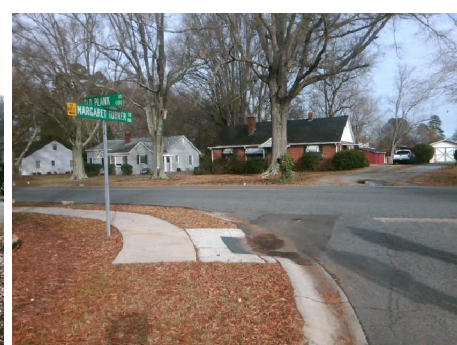
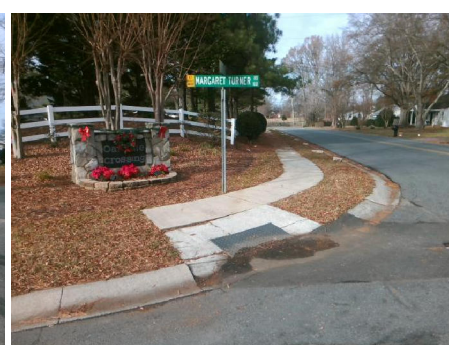
Possible Solutions:		Compliance	Description	Data	Compliance	Description	Data
	Remove & Replace Entire Ramp.		N/A	Ramp Length (in)	51.0	No	Ramp Slope (%)	15.2
			Yes	Ramp Width (in)	86.5	No	Ramp XSlope (%)	2.4
			N/A	Flare Type LT	N/A	N/A	Flare Type RT	N/A
			N/A	Flare Slope LT (%)	N/A	N/A	Flare Slope RT (%)	N/A
			N/A	Flare Traversable LT?	N/A	N/A	Flare Traversable RT?	N/A
			N/A	Landing Length (in)	N/A	N/A	DWS Provided?	N/A
			N/A	Landing Width (in)	N/A	N/A	DWS Contrast?	N/A
			N/A	Landing Slope (%)	N/A	N/A	DWS Length (in)	N/A
			N/A	Landing X Slope (%)	N/A	N/A	DWS Full Width?	N/A
Surveyor Notes:		N/A	N/A	Landing Curb? (Y/N)	N/A	N/A	DWS Offset (in)	N/A
PROW/ADA:		Not Found, R304.2.2, R304.5.3	N/A	Shared Landing?	N/A			
			N/A	Gutter Ponding?	Yes	N/A	Gutter Slope (%)	N/A
			N/A	Gutter Lip Ht (in)	N/A	N/A	Gutter X Slope (%)	N/A

N/A	Painted X Walk1?	No	N/A	Painted X Walk2?	N/A
				X Walk 1 Direction	To S		X Walk 2 Direction	N/A
			N/A	X Walk 1 Width (in)	N/A	N/A	X Walk 2 Width (in)	N/A
				X Walk 1 Slope (%)	3.2		X Walk 2 Slope (%)	N/A
				X Walk 1 X Slope (%)	2.7		X Walk 2 X Slope (%)	N/A
			N/A	Ramp inside XWalk1?	N/A	N/A	Ramp inside XWalk2?	N/A
				Road Slope (%)	N/A	N/A	Clear Space?	N/A
				Road X Slope (%)	N/A	N/A	Clear Space to XWalk (in)	N/A
			N/A	Any Obstructions?	N/A	N/A	Storm Grate/Utility Hazard?	N/A
				Obstruction Type			Storm Grate/Utility Type	
					N/A			N/A
						Yes	Surface Condition? (G/P)	Good
Total Cost:		\$ 1850.00						
Street 1 Name MARGARET TURNER RD								
Stop Condition-Street 2 StopSign								
Street 2 Name N/A								
Stop Condition-Street 1 N/A
