Access Compliance Report

Public Rights-of-Way

(Curb Ramps)

Intersection ID: 23292	Main Street: SHARON_RD_WEST	Cross Street: RIVERBIRCH_DR	Location: SE
ADA ID: D454FE82203B	Ramp Type: PerpDiag	Initial Pass/Fail: Fail	Overall Compliance: No
Severity Score: 22.5			
Codes/Mitigation Info/Possible Solution		Field Measurements/Component Compliance

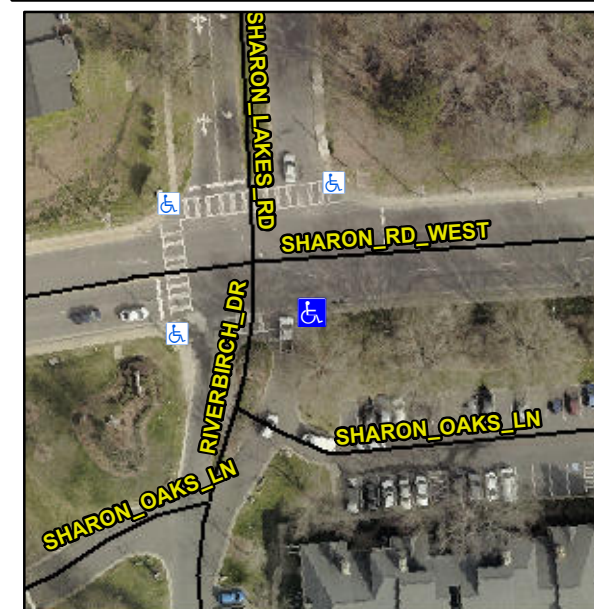
Not Found, R304.5.1, R304.2.2

Compliance	Description	Data	Compliance	Description	Data
N/A	Ramp Length (in)	58.0	No	Ramp Slope (%)	11.6
No	Ramp Width (in)	41.0	Yes	Ramp XSlope (%)	2.1
N/A	Flare Type LT	N/A	N/A	Flare Type RT	N/A
N/A	Flare Slope LT (%)	N/A	N/A	Flare Slope RT (%)	N/A
N/A	Flare Traversable LT?	N/A	N/A	Flare Traversable RT?	N/A
N/A	Landing Length (in)	N/A	N/A	DWS Provided?	N/A
N/A	Landing Width (in)	N/A	N/A	DWS Contrast?	N/A
N/A	Landing Slope (%)	N/A	N/A	DWS Length (in)	N/A
N/A	Landing X Slope (%)	N/A	N/A	DWS Full Width?	N/A
N/A	Landing Curb? (Y/N)	N/A	N/A	DWS Offset (in)	N/A
N/A	Shared Landing?	N/A			
N/A	Gutter Ponding?	N/A	N/A	Gutter Slope (%)	N/A
N/A	Gutter Lip Ht (in)	N/A	N/A	Gutter X Slope (%)	N/A
N/A	Painted X Walk1?	No	N/A	Painted X Walk2?	Yes
	X Walk 1 Direction	To NE		X Walk 2 Direction	To W
N/A	X Walk 1 Width (in)	N/A	N/A	X Walk 2 Width (in)	104.0
	X Walk 1 Slope (%)	2.7		X Walk 2 Slope (%)	1.0
	X Walk 1 X Slope (%)	1.4		X Walk 2 X Slope (%)	1.6

N/A	Ramp inside XWalk1?	N/A	N/A	Ramp inside XWalk2?	Yes
	Road Slope (%)	2.6	N/A	Clear Space?	N/A
	Road X Slope (%)	3.4	N/A	Clear Space to XWalk (in)	N/A
N/A	Any Obstructions?	N/A	N/A	Storm Grate/Utility Hazard?	N/A
	Obstruction Type			Storm Grate/Utility Type	
		N/A			N/A
			Yes	Surface Condition? (G/P)	Good

Possible Solutions:

Remove & Replace Curb Ramp With Two New Directional Ramps or Equivalent.
