# Access Compliance Report

## Public Rights-of-Way

### (Curb Ramps)

Intersection ID: 22758	Main Street: RIDGE_OAK_DR	Cross Street: MOSS_RD	Location: SW
ADA ID: D46A3F95C209	Ramp Type: Perp	Initial Pass/Fail: Fail	Overall Compliance: No
Severity Score: 8.75			
Codes/Mitigation Info/Possible Solution		Field Measurements/Component Compliance

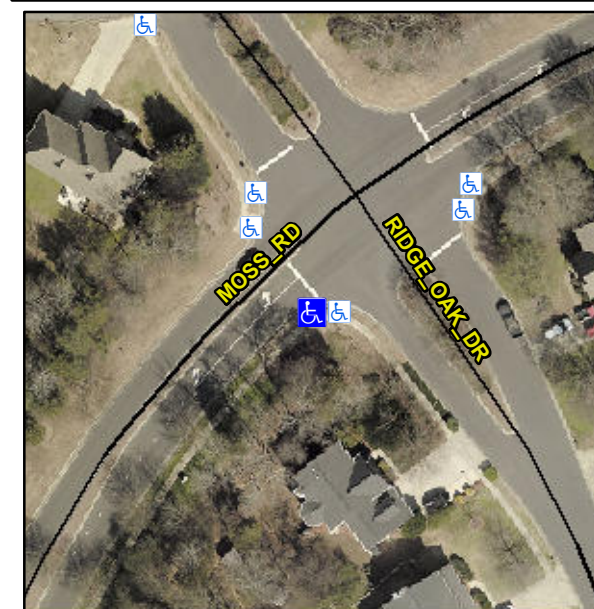
PROW/ADA:

**Not Found, R304.5.1**

Compliance	Description	Data	Compliance	Description	Data
N/A	Ramp Length (in)	99.0	Yes	Ramp Slope (%)	5.9
No	Ramp Width (in)	39.0	Yes	Ramp XSlope (%)	0.5
N/A	Flare Type LT	N/A	N/A	Flare Type RT	N/A
N/A	Flare Slope LT (%)	N/A	N/A	Flare Slope RT (%)	N/A
N/A	Flare Traversable LT?	N/A	N/A	Flare Traversable RT?	N/A
N/A	Landing Length (in)	N/A	N/A	DWS Provided?	N/A
N/A	Landing Width (in)	N/A	N/A	DWS Contrast?	N/A
N/A	Landing Slope (%)	N/A	N/A	DWS Length (in)	N/A
N/A	Landing X Slope (%)	N/A	N/A	DWS Full Width?	N/A
N/A	Landing Curb? (Y/N)	N/A	N/A	DWS Offset (in)	N/A
N/A	Shared Landing?	N/A			
N/A	Gutter Ponding?	N/A	N/A	Gutter Slope (%)	N/A
N/A	Gutter Lip Ht (in)	N/A	N/A	Gutter X Slope (%)	N/A
N/A	Painted X Walk1?	No	N/A	Painted X Walk2?	N/A
	X Walk 1 Direction	To NW		X Walk 2 Direction	N/A
N/A	X Walk 1 Width (in)	N/A	N/A	X Walk 2 Width (in)	N/A
	X Walk 1 Slope (%)	1.5		X Walk 2 Slope (%)	N/A
	X Walk 1 X Slope (%)	0.7		X Walk 2 X Slope (%)	N/A

N/A	Ramp inside XWalk1?	N/A	N/A	Ramp inside XWalk2?	N/A
	Road Slope (%)	N/A	N/A	Clear Space?	N/A
	Road X Slope (%)	N/A	N/A	Clear Space to XWalk (in)	N/A
N/A	Any Obstructions?	N/A	N/A	Storm Grate/Utility Hazard?	N/A
	Obstruction Type			Storm Grate/Utility Type	
		N/A			N/A
		Yes		Surface Condition? (G/P)	Good

Possible Solutions:

**Remove & Replace Entire Ramp.**
