# Access Compliance Report

## Public Rights-of-Way

### (Curb Ramps)

Intersection ID: 16388	Main Street: BILLINGSLEY_RD	Cross Street: CASCADE_CR	Location: SW
ADA ID: D46E72BC5E50	Ramp Type: PerpDiag	Initial Pass/Fail: Fail	Overall Compliance: No
			Severity Score: 31.25

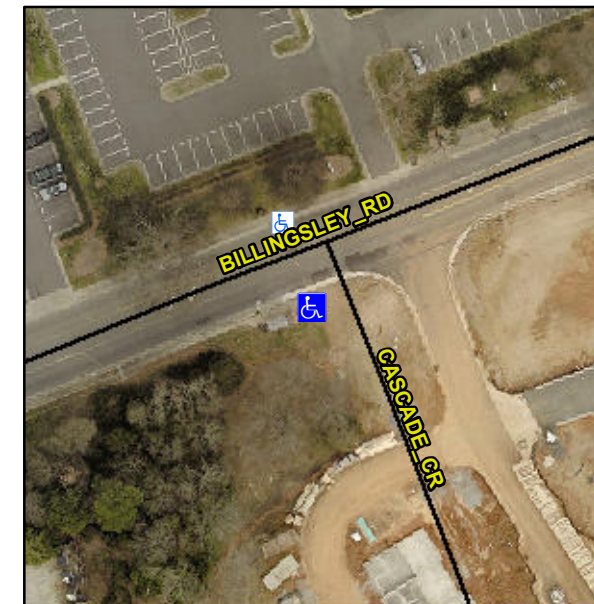
**Not Found, R304.5.1, R304.2.2, R304.5.3**

Compliance	Description	Data	Compliance	Description	Data
N/A	Ramp Length (in)	60.0	No	Ramp Slope (%)	8.6
No	Ramp Width (in)	33.0	No	Ramp XSlope (%)	3.5
N/A	Flare Type LT	N/A	N/A	Flare Type RT	N/A
N/A	Flare Slope LT (%)	N/A	N/A	Flare Slope RT (%)	N/A
N/A	Flare Traversable LT?	N/A	N/A	Flare Traversable RT?	N/A
N/A	Landing Length (in)	N/A	N/A	DWS Provided?	N/A
N/A	Landing Width (in)	N/A	N/A	DWS Contrast?	N/A
N/A	Landing Slope (%)	N/A	N/A	DWS Length (in)	N/A
N/A	Landing X Slope (%)	N/A	N/A	DWS Full Width?	N/A
N/A	Landing Curb? (Y/N)	N/A	N/A	DWS Offset (in)	N/A
N/A	Shared Landing?	N/A			
N/A	Gutter Ponding?	N/A	N/A	Gutter Slope (%)	N/A
N/A	Gutter Lip Ht (in)	N/A	N/A	Gutter X Slope (%)	N/A
N/A	Painted X Walk1?	No	N/A	Painted X Walk2?	No
	X Walk 1 Direction	To E		X Walk 2 Direction	To N
N/A	X Walk 1 Width (in)	N/A	N/A	X Walk 2 Width (in)	N/A
	X Walk 1 Slope (%)	1.7		X Walk 2 Slope (%)	5.9
	X Walk 1 X Slope (%)	3.9		X Walk 2 X Slope (%)	2.9

N/A	Ramp inside XWalk1?	N/A	N/A	Ramp inside XWalk2?	N/A
	Road Slope (%)	3.4	N/A	Clear Space?	N/A
	Road X Slope (%)	9.0	N/A	Clear Space to XWalk (in)	N/A
N/A	Any Obstructions?	N/A	N/A	Storm Grate/Utility Hazard?	N/A
	Obstruction Type			Storm Grate/Utility Type	
		N/A			N/A
			Yes	Surface Condition? (G/P)	Good

**Remove & Replace Curb Ramp With Two New Directional Ramps or Equivalent.**

Total Cost: \$ 3200.00
