Access Compliance Report

Public Rights-of-Way

(Curb Ramps)

Intersection ID: 10023414	Main Street: CHOATE_CR	Cross Street: N/A	Location: W
ADA ID: D4730DBB3B4D	Ramp Type: BlendTrans2	Initial Pass/Fail: Fail	Overall Compliance: No
		Severity Score: 10

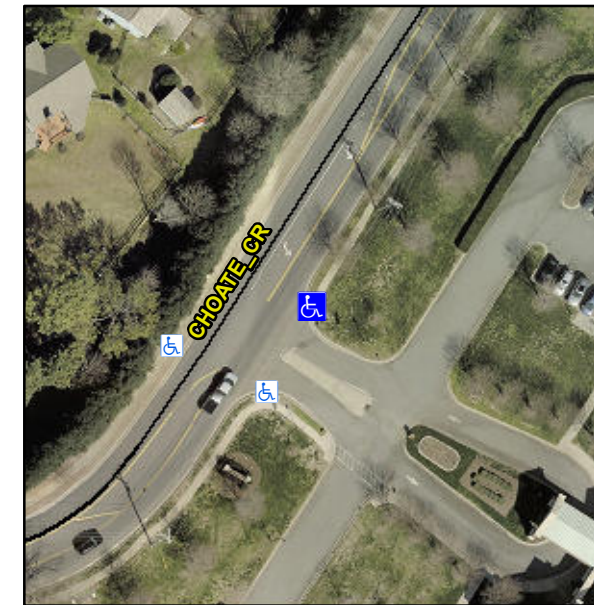
Compliance	Description	Data	Compliance	Description	Data
N/A	Ramp Length (in)	96.0	Yes	BlendTrans Slope (%)	4.5
No	Ramp Width (in)	37.5	No	BlendTrans XSlope (%)	3.8
N/A	Flare Type LT	N/A	N/A	Flare Type RT	N/A
N/A	Flare Slope LT (%)	N/A	N/A	Flare Slope RT (%)	N/A
N/A	Flare Traversable LT?	N/A	N/A	Flare Traversable RT?	N/A
N/A	Landing Length (in)	N/A	N/A	DWS Provided?	N/A
N/A	Landing Width (in)	N/A	N/A	DWS Contrast?	N/A
N/A	Landing Slope (%)	N/A	N/A	DWS Length (in)	N/A
N/A	Landing X Slope (%)	N/A	N/A	DWS Full Width?	N/A
N/A	Landing Curb? (Y/N)	N/A	N/A	DWS Offset (in)	N/A
N/A	Shared Landing?	N/A			
N/A	Gutter Ponding?	N/A	N/A	Gutter Slope (%)	N/A
N/A	Gutter Lip Ht (in)	N/A	N/A	Gutter X Slope (%)	N/A
N/A	Painted X Walk1?	No	N/A	Painted X Walk2?	No
	X Walk 1 Direction	To NW		X Walk 2 Direction	To SW
	X Walk 1 Width (in)	N/A		X Walk 2 Width (in)	N/A
	X Walk 1 Slope (%)	10.8		X Walk 2 Slope (%)	5.1
	X Walk 1 X Slope (%)	3.2		X Walk 2 X Slope (%)	3.9

N/A	Ramp inside XWalk1?	N/A	N/A	Ramp inside XWalk2?	N/A
	Road Slope (%)	3.5		Clear Space?	N/A
	Road X Slope (%)	3.2	N/A	Clear Space to XWalk (in)	N/A
N/A	Any Obstructions?	N/A	N/A	Storm Grate/Utility Hazard?	N/A
	Obstruction Type			Storm Grate/Utility Type	
		N/A			N/A
			Yes	Surface Condition? (G/P)	Good
			N/A	Curb Slope (%)	3.9

Remove & Replace Curb Ramp With Two New Directional Ramps or Equivalent.
