Access Compliance Report

Public Rights-of-Way

(Curb Ramps)

Intersection ID: 50583	Main Street: GRAND_FIR_RD	Cross Street: LONGSTRAW_RD	Location: SW
ADA ID: D475727B9FD8	Ramp Type: Perp	Initial Pass/Fail: Pass	Overall Compliance: No
Severity Score: 0.25			
Codes/Mitigation Info/Possible Solution		Field Measurements/Component Compliance

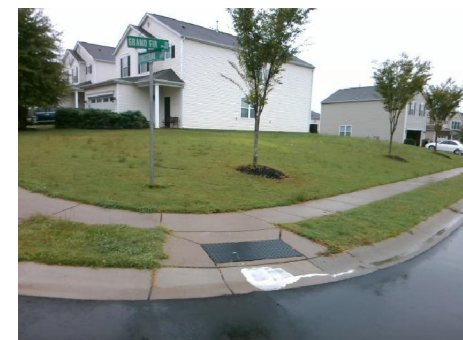
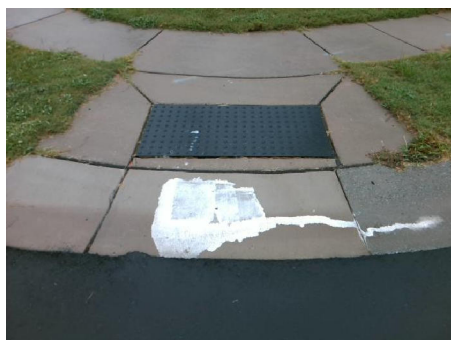
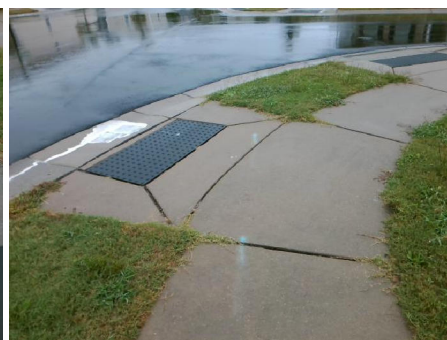
Not Found, R304.5.3, R305.2

Compliance	Description	Data	Compliance	Description	Data
N/A	Ramp Length (in)	48.0	Yes	Ramp Slope (%)	6.4
Yes	Ramp Width (in)	48.0	No	Ramp XSlope (%)	5.0
N/A	Flare Type LT	Sloped	N/A	Flare Type RT	N/A
N/A	Flare Slope LT (%)	10.3	N/A	Flare Slope RT (%)	2.1
N/A	Flare Traversable LT?	No	N/A	Flare Traversable RT?	No
Yes	Landing Length (in)	49.0	Yes	DWS Provided?	Yes
Yes	Landing Width (in)	48.0	Yes	DWS Contrast?	Yes
Yes	Landing Slope (%)	0.8	Yes	DWS Length (in)	24.0
No	Landing X Slope (%)	6.7	Yes	DWS Full Width?	Yes
N/A	Landing Curb? (Y/N)	No	No	DWS Offset (in)	5.5
N/A	Shared Landing?	No			
Yes	Gutter Ponding?	No	Yes	Gutter Slope (%)	3.9
Yes	Gutter Lip Ht (in)	0.0	No	Gutter X Slope (%)	4.4
N/A	Painted X Walk1?	No	N/A	Painted X Walk2?	N/A
	X Walk 1 Direction	To N		X Walk 2 Direction	N/A
N/A	X Walk 1 Width (in)	N/A	N/A	X Walk 2 Width (in)	N/A
	X Walk 1 Slope (%)	0.4		X Walk 2 Slope (%)	N/A
	X Walk 1 X Slope (%)	2.9		X Walk 2 X Slope (%)	N/A

N/A	Ramp inside XWalk1?	N/A	N/A	Ramp inside XWalk2?	N/A
	Road Slope (%)	N/A	N/A	Clear Space?	Yes
	Road X Slope (%)	N/A	N/A	Clear Space to XWalk (in)	N/A
Yes	Any Obstructions?	No	Yes	Storm Grate/Utility Hazard?	No
	Obstruction Type			Storm Grate/Utility Type	
		N/A			N/A
			Yes	Surface Condition? (G/P)	Good

Possible Solutions:

**Remove & Replace Entire Ramp.
Remove & Replace Gutter.**
