Access Compliance Report

Public Rights-of-Way

(Curb Ramps)

Intersection ID: 48954	Main Street: ROYA_PL	Cross Street: JOSHUA_CAIN_RD	Location: S
ADA ID: D475E825C6D5	Ramp Type: Perp	Initial Pass/Fail: Fail	Overall Compliance: No
			Severity Score: 21.25

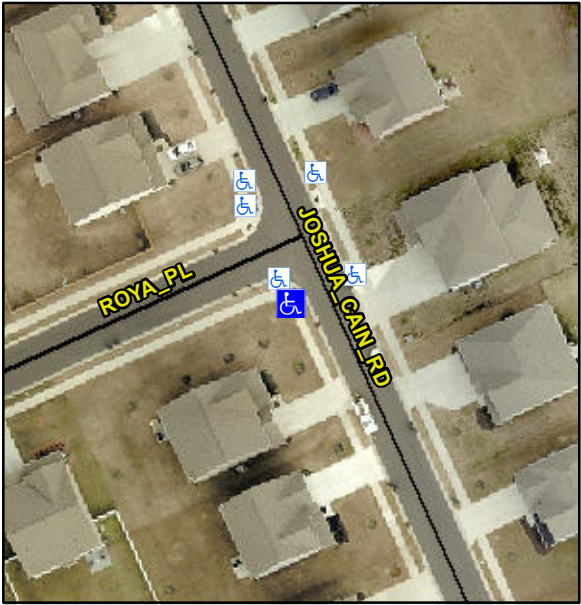
Possible Solutions:		Compliance	Description	Data
	Remove & Replace Entire Ramp.		No	Ramp Length (in)	59.5
			No	Ramp Width (in)	46.5
			N/A	Flare Type LT	N/A
			N/A	Flare Slope LT (%)	N/A
			N/A	Flare Traversable LT?	N/A
			N/A	Landing Length (in)	N/A
			N/A	Landing Width (in)	N/A
			N/A	Landing Slope (%)	N/A
			N/A	Landing X Slope (%)	N/A
<p>Surveyor Notes:</p> <p>N/A</p> <p>PROW/ADA:</p> <p>R304.5.1, R304.2.2</p>			N/A	Flare Type RT	N/A
			N/A	Flare Slope RT (%)	N/A
			N/A	Flare Traversable RT?	N/A
			N/A	DWS Provided?	N/A
			N/A	DWS Contrast?	N/A
			N/A	DWS Length (in)	N/A
			N/A	DWS Full Width?	N/A
			N/A	DWS Offset (in)	N/A
			N/A	Shared Landing?	N/A
			N/A	Gutter Ponding?	N/A
<p>Total Cost:</p> <p>\$ 1850.00</p>			N/A	Gutter Lip Ht (in)	1.5
			N/A	Painted X Walk1?	No
				X Walk 1 Direction	To E
			N/A	X Walk 1 Width (in)	N/A

X Walk 1 Slope (%)	0.9
				X Walk 1 X Slope (%)	0.2
			N/A	Ramp inside XWalk1?	N/A
				Road Slope (%)	N/A
				Road X Slope (%)	N/A
			N/A	Any Obstructions?	N/A
				Obstruction Type	
			N/A		N/A
			Yes	Surface Condition? (G/P)	Good
