# Access Compliance Report

## Public Rights-of-Way

| Intersection ID: 52718 | Main Street: AGAVA_LN | Cross Street: MAIDENHAIR_CT | Location: S |
| ADA ID: D47C080B7B59 | Ramp Type: BlendTrans1 | Initial Pass/Fail: Pass | Overall Compliance: No |

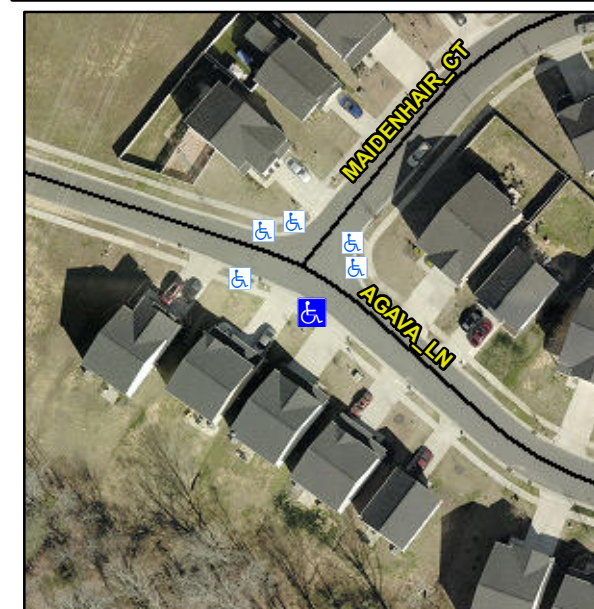
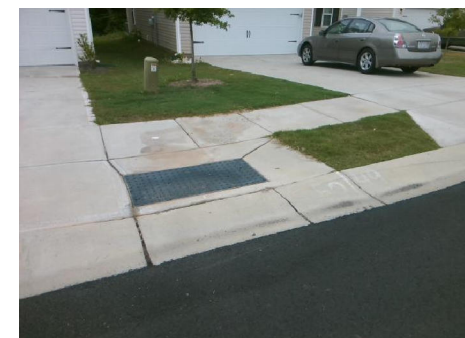
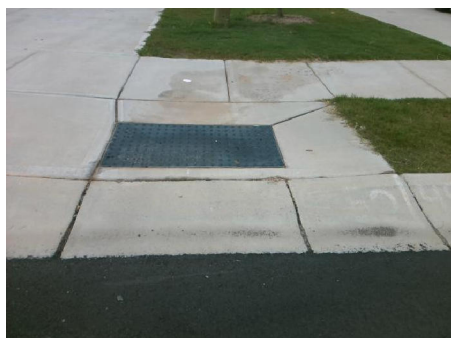
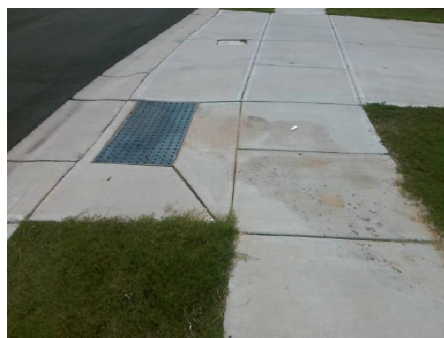
**Not Found, R304.2.2-Perp, R304.3.2-Para, R305.2, R302.7, R304.5.4**

| Compliance | Description | Data | Compliance | Description | Data |
|---|---|---|---|---|---|
| No | Landing Slope (%) | 2.2 | Yes | DWS Length (in) | 24.0 |
| N/A | Landing Curb? (Y/N) | No | No | DWS Offset (in) | 5.5 |
| No | Gutter Ponding? | Yes | No | Gutter Slope (%) | 12.5 |
| | | | No | Curb Slope (%) | 13.2 |

**Remove & Replace Curb Ramp With Two New Directional Ramps or Equivalent. Remove & Replace Gutter.**
