# Access Compliance Report

## Public Rights-of-Way

### (Curb Ramps)

| Intersection ID: N/A | Main Street: ELEANOR_RIGBY_RD | Cross Street: MAGGIE_MAY_LN | Location: SW |

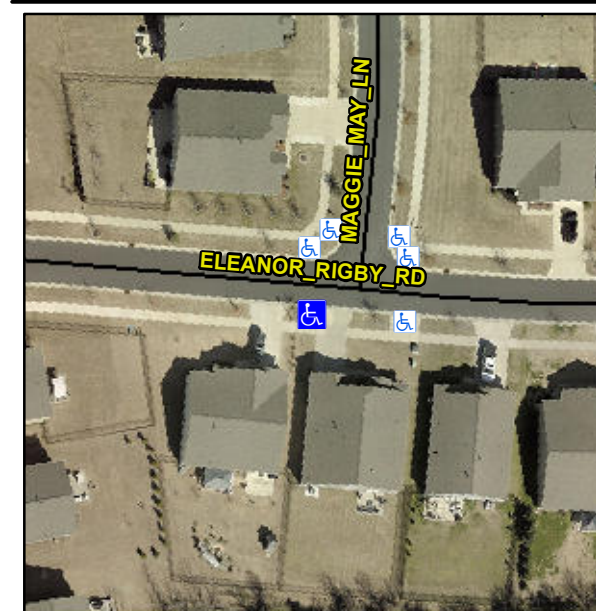
| Compliance | Description | Data | Compliance | Description | Data |
|---|---|---|---|---|---|
| No | Landing Slope (%) | 2.2 | Yes | DWS Length (in) | 24.0 |
| No | Landing X Slope (%) | 3.1 | Yes | DWS Full Width? | Yes |
| Yes | Gutter Ponding? | No | No | Gutter Slope (%) | 8.1 |

Possible Solutions:

**Remove & Replace Landing.  
Remove & Replace Gutter.**
