# Access Compliance Report

## Public Rights-of-Way

### (Curb Ramps)

Intersection ID: 5031	Main Street: OLD_STATESVILLE_RD	Cross Street: AIRWAY_AV	Location: W
ADA ID: D484A4753739	Ramp Type: Perp	Initial Pass/Fail: Fail	Overall Compliance: No
Severity Score: 21.25			
Codes/Mitigation Info/Possible Solution		Field Measurements/Component Compliance

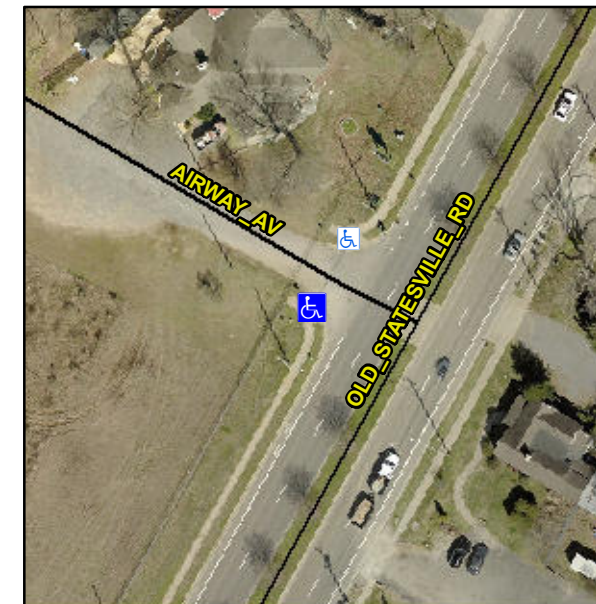
**Not Found, R304.5.1, R304.2.2**

Compliance	Description	Data	Compliance	Description	Data
N/A	Ramp Length (in)	53.0	No	Ramp Slope (%)	9.5
No	Ramp Width (in)	39.0	Yes	Ramp XSlope (%)	0.6
N/A	Flare Type LT	N/A	N/A	Flare Type RT	N/A
N/A	Flare Slope LT (%)	N/A	N/A	Flare Slope RT (%)	N/A
N/A	Flare Traversable LT?	N/A	N/A	Flare Traversable RT?	N/A
N/A	Landing Length (in)	N/A	N/A	DWS Provided?	N/A
N/A	Landing Width (in)	N/A	N/A	DWS Contrast?	N/A
N/A	Landing Slope (%)	N/A	N/A	DWS Length (in)	N/A
N/A	Landing X Slope (%)	N/A	N/A	DWS Full Width?	N/A
N/A	Landing Curb? (Y/N)	N/A	N/A	DWS Offset (in)	N/A
N/A	Shared Landing?	N/A			
N/A	Gutter Ponding?	N/A	N/A	Gutter Slope (%)	N/A
N/A	Gutter Lip Ht (in)	N/A	N/A	Gutter X Slope (%)	N/A
N/A	Painted X Walk1?	No	N/A	Painted X Walk2?	N/A
	X Walk 1 Direction	To NE		X Walk 2 Direction	N/A
N/A	X Walk 1 Width (in)	N/A	N/A	X Walk 2 Width (in)	N/A
	X Walk 1 Slope (%)	0.6		X Walk 2 Slope (%)	N/A
	X Walk 1 X Slope (%)	0.5		X Walk 2 X Slope (%)	N/A

N/A	Ramp inside XWalk1?	N/A	N/A	Ramp inside XWalk2?	N/A
	Road Slope (%)	N/A	N/A	Clear Space?	N/A
	Road X Slope (%)	N/A	N/A	Clear Space to XWalk (in)	N/A
N/A	Any Obstructions?	N/A	N/A	Storm Grate/Utility Hazard?	N/A
	Obstruction Type			Storm Grate/Utility Type	
		N/A			N/A
			Yes	Surface Condition? (G/P)	Good

**Remove & Replace Entire Ramp.**

Total Cost: \$ 1850.00
