# Access Compliance Report

## Public Rights-of-Way

### (Curb Ramps)

Intersection ID: 12715	Main Street: DUNBAR_ST	Cross Street: S_MINT_ST	Location: N
ADA ID: D49A59460CE4	Ramp Type: Directional1	Initial Pass/Fail: Fail	Overall Compliance: No
Severity Score: 58.75			
Codes/Mitigation Info/Possible Solution		Field Measurements/Component Compliance

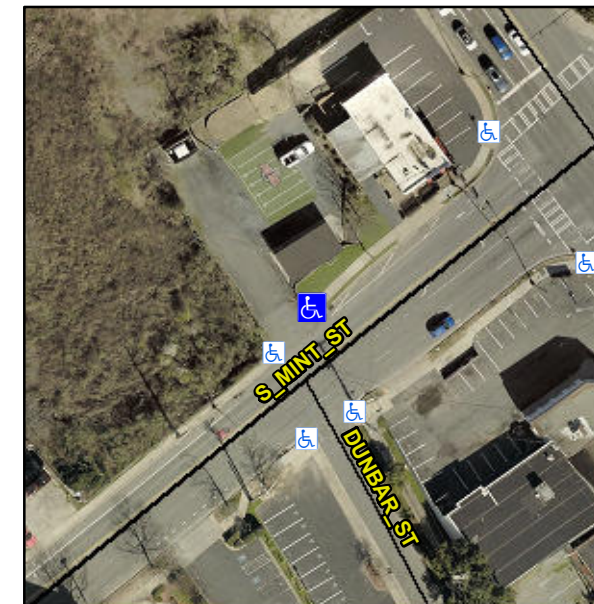
**R304.5.1, R304.2.2, R304.5.3**

Compliance	Description	Data	Compliance	Description	Data
N/A	Ramp Length (in)	77.0	N/A	Grade Break?	N/A
No	Ramp Width (in)	44.5	N/A	Grade Break Slope (%)	0.0
No	Ramp Slope (%)	12.3	N/A	Grade Break XSlope (%)	0.0
No	Ramp XSlope (%)	8.5			
N/A	Flare Type LT	N/A	N/A	Flare Type RT	N/A
N/A	Flare Slope LT (%)	N/A	N/A	Flare Slope RT (%)	0.0
N/A	Flare Traversable LT?	N/A	N/A	Flare Traversable RT?	N/A
N/A	Landing Length (in)	0.0	N/A	DWS Provided?	N/A
N/A	Landing Width (in)	0.0	N/A	DWS Contrast?	N/A
N/A	Landing Slope (%)	0.0	N/A	DWS Length (in)	N/A
N/A	Landing X Slope (%)	0.0	N/A	DWS Full Width?	N/A
N/A	Landing Curb? (Y/N)	N/A	N/A	DWS Offset LT (in)	N/A
N/A	Shared Landing?	N/A	N/A	DWS Offset RT (in)	N/A
N/A	Gutter Ponding?	0.0	N/A	Gutter Slope (%)	N/A
N/A	Gutter Lip Ht (in)	0.0	N/A	Gutter X Slope (%)	N/A
N/A	Painted X Walk1?	No		Road Slope (%)	1.4
	X Walk 1 Direction	To SW		Road X Slope (%)	4.2
	X Walk 1 Width (in)	N/A		Clear Space?	N/A

X Walk 1 Slope (%)	1.4	N/A	Clear Space to XWalk (in)	N/A
	X Walk 1 X Slope (%)	4.2	N/A	Storm Grate/Utility Hazard?	N/A
N/A	Ramp inside XWalk1?	N/A		Storm Grate/Utility Type	
N/A	Any Obstructions?	N/A			N/A
	Obstruction Type		Yes	Surface Condition? (G/P)	Good
			N/A	Curb Slope (%)	8.8

**Remove & Replace Entire Ramp.**

Total Cost: \$ 1600.00
