# Access Compliance Report

## Public Rights-of-Way

### (Curb Ramps)

| Intersection ID: 29650 | Main Street: MILLERS_CREEK_LN | Cross Street: SOUTHERN_GARDEN_LN | Location: NW |

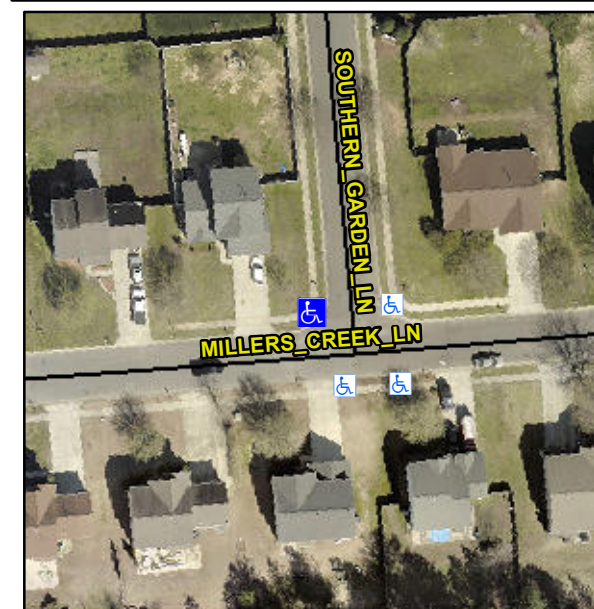
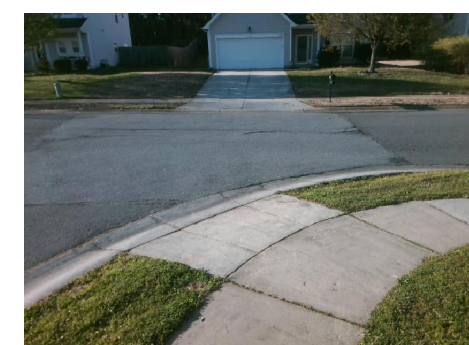
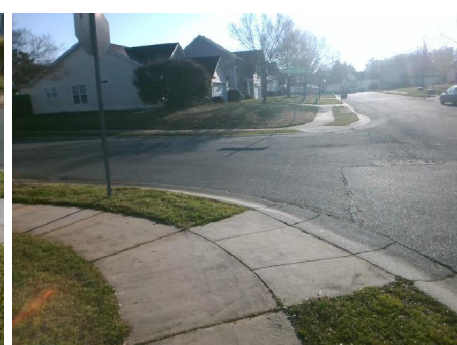
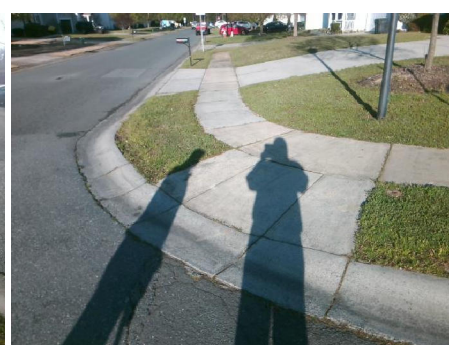
| ADA ID: D49AB5FFCC87 | Ramp Type: PerpDiag | Initial Pass/Fail: Fail | Overall Compliance: No |

**Not Found, R304.5.1, R304.2.2, R304.5.3**

| Compliance | Description | Data | Compliance | Description | Data |
|---|---|---|---|---|---|
| N/A | Ramp Length (in) | 59.0 | No | Ramp Slope (%) | 11.9 |
| No | Ramp Width (in) | 33.0 | No | Ramp XSlope (%) | 2.1 |

**Remove & Replace Curb Ramp With Two New Directional Ramps or Equivalent.**
