Access Compliance Report Public Rights-of-Way (Curb Ramps)

Intersection ID: 10025398 Main Street: E_ARROWOOD_RD Cross Street: S_OAK_MARKETPLACE_DR Location: SE

ADA ID: D4C730E0DB82 Ramp Type: Directional1 Initial Pass/Fail: Fail Overall Compliance: No Severity Score: 25

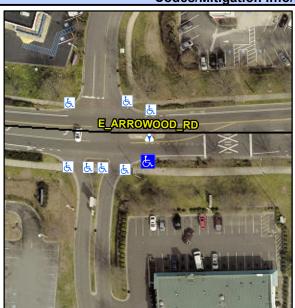
| Possible Solutions: | С | | |
|---|---|--|--|
| R304.5.3 | N | | |

| Field Measurements/Component Compliance | | | | | | | | |
|---|---|---|---|---|---|--|--|--|
| No | Ramp XSlope (%) | 8.0 | | | | | | |

| Possible Solutions: | С | | |
|---|---|--|--|
| Remove & Replace Entire Ramp. | | | |

| Total Cost: | \$ 1600.00 |
