## **Access Compliance Report Public Rights-of-Way** (Curb Ramps)

Intersection ID: 30340 Main Street: DULIN\_CREEK\_BV Cross Street: FOX\_SWAMP\_RD Location: NW **Overall Compliance: No Severity Score: ADA ID: D4CA6414A29B** Ramp Type: PerpDiag Initial Pass/Fail: Fail 10

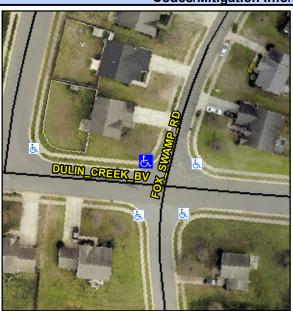
Field Measurements/Component Compliance								
	Compliance Description		Data	Compliance Description		Description	Data	
	N/A	Ramp Length (in)	42.0	Yes	Ramp	Slope (%)	5.3	
	No	Ramp Width (in)	47.0	No	Ramp	XSlope (%)	3.7	
	N/A	Flare Type LT	N/A	N/A	Flare	Type RT	N/A	
	N/A	Flare Slope LT (%)	N/A	N/A	Flare	Slope RT (%)	N/A	
	N/A	Flare Traversable LT?	N/A	N/A	Flare	Traversable RT?	N/A	
	N/A	Landing Length (in)	N/A	N/A	DWS	Provided?	N/A	
	N/A	Landing Width (in)	N/A	N/A	DWS	Contrast?	N/A	
	N/A	Landing Slope (%)	N/A	N/A	DWS	Length (in)	N/A	
	N/A	Landing X Slope (%)	N/A	N/A	DWS	Full Width?	N/A	
	N/A	Landing Curb? (Y/N)	N/A	N/A	DWS	Offset (in)	N/A	
	N/A	Shared Landing?	N/A					
	N/A	Gutter Ponding?	N/A	N/A	Gutte	r Slope (%)	N/A	
	N/A	Gutter Lip Ht (in)	N/A	N/A	Gutte	r X Slope (%)	N/A	
	N/A	Painted X Walk1?	No	N/A	Paint	ed X Walk2?	No	
		X Walk 1 Direction	To S		X Wa	lk 2 Direction	ТоЕ	
	N/A	X Walk 1 Width (in)	N/A	N/A	X Wa	lk 2 Width (in)	N/A

X Walk 1 Slope (%)	3.3		X Wa	lk 2 Slope (%)	0.2	
		X Walk 1 X Slope (%)	2.4		X Wa	lk 2 X Slope (%)	1.3	
	N/A	Ramp inside XWalk1?	N/A	N/A	Ramp	inside XWalk2?	N/A	
		Road Slope (%)	1.4	N/A	Clear	Space?	N/A	
		Road X Slope (%)	0.2	N/A	Clear	Space to XWalk (in)	N/A	
	N/A	Any Obstructions?	N/A	N/A	Storm	n Grate/Utility Hazard?	N/A	
		Obstruction Type			Storm	n Grate/Utility Type		
			N/A				N/A	
				Yes	Surfa	ce Condition? (G/P)	Good

Possible Solutions:
Remove & Replace Curb Ramp With Two New Directional Ramps or Equivalent.
Surveyor Notes: N/A
PROW/ADA: Not Found, R304.5.1, R304.5.3
