Access Compliance Report

Public Rights-of-Way

(Curb Ramps)

Intersection ID: 44602	Main Street: JOHNSTON_OEHLER_RD	Cross Street: PROSPERITY_PARK_DR	Location: NW
ADA ID: D4CA65AC36D9	Ramp Type: PerpDiag	Initial Pass/Fail: Fail	Overall Compliance: No
Codes/Mitigation Info/Possible Solution		Field Measurements/Component Compliance

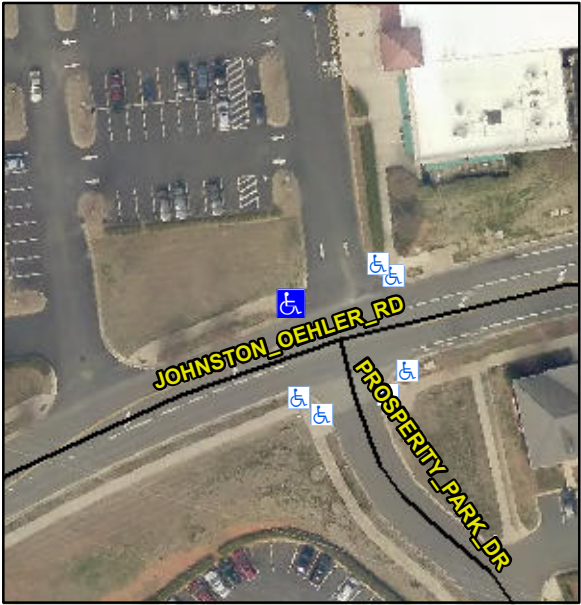
Possible Solutions:	Compliance	Description	Data	Compliance	Description	Data
	Remove & Replace Curb Ramp With Two New Directional Ramps or Equivalent.	N/A	Ramp Length (in)	70.0	No	Ramp Slope (%)	20.0
<p>Surveyor Notes:</p> <p>N/A</p> <p>PROW/ADA:</p> <p>R304.5.1, R304.2.2</p>		No	Ramp Width (in)	38.5	Yes	Ramp XSlope (%)	1.6
		N/A	Flare Type LT	N/A	N/A	Flare Type RT	N/A
		N/A	Flare Slope LT (%)	N/A	N/A	Flare Slope RT (%)	N/A
		N/A	Flare Traversable LT?	N/A	N/A	Flare Traversable RT?	N/A
		N/A	Landing Length (in)	N/A	N/A	DWS Provided?	N/A
		N/A	Landing Width (in)	N/A	N/A	DWS Contrast?	N/A
		N/A	Landing Slope (%)	N/A	N/A	DWS Length (in)	N/A
		N/A	Landing X Slope (%)	N/A	N/A	DWS Full Width?	N/A
		N/A	Landing Curb? (Y/N)	N/A	N/A	DWS Offset (in)	N/A
		N/A	Shared Landing?	N/A			
		N/A	Gutter Ponding?	N/A	N/A	Gutter Slope (%)	N/A
		N/A	Gutter Lip Ht (in)	1.0	N/A	Gutter X Slope (%)	N/A
		N/A	Painted X Walk1?	No	N/A	Painted X Walk2?	No

X Walk 1 Direction	To E		X Walk 2 Direction	To S
		N/A	X Walk 1 Width (in)	N/A	N/A	X Walk 2 Width (in)	N/A
			X Walk 1 Slope (%)	1.4		X Walk 2 Slope (%)	1.2
			X Walk 1 X Slope (%)	1.6		X Walk 2 X Slope (%)	2.1
		N/A	Ramp inside XWalk1?	N/A	N/A	Ramp inside XWalk2?	N/A
			Road Slope (%)	0.0	N/A	Clear Space?	N/A
			Road X Slope (%)	0.6	N/A	Clear Space to XWalk (in)	N/A
		N/A	Any Obstructions?	N/A	N/A	Storm Grate/Utility Hazard?	N/A
			Obstruction Type			Storm Grate/Utility Type	
					N/A		N/A
					Yes	Surface Condition? (G/P)	Good
