Access Compliance Report

Public Rights-of-Way

(Curb Ramps)

| Intersection ID: 49307 | Main Street: CAYMAN_WY | Cross Street: JOSHUA_LN | Location: NW |

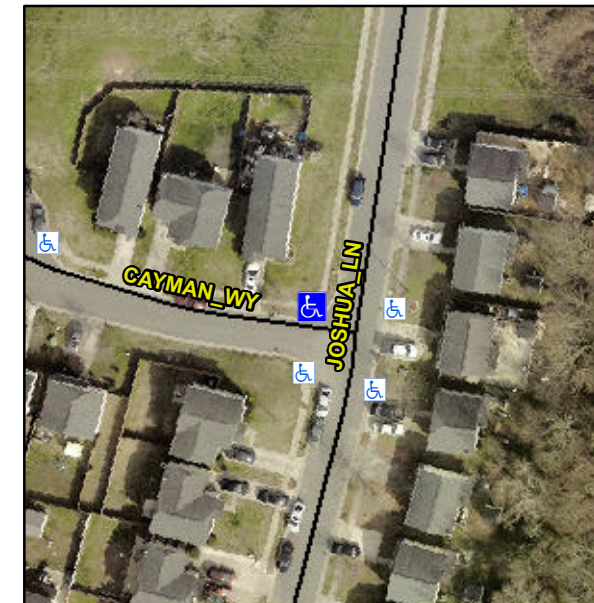
| ADA ID: D4D21176986E | Ramp Type: PerpDiag | Initial Pass/Fail: Fail | Overall Compliance: No |

Not Found, R304.5.1, R304.2.2, R304.5.3

| Compliance | Description | Data | Compliance | Description | Data |
|---|---|---|---|---|---|
| N/A | Ramp Length (in) | 46.5 | No | Ramp Slope (%) | 8.4 |
| No | Ramp Width (in) | 36.0 | No | Ramp XSlope (%) | 4.6 |

Remove & Replace Curb Ramp With Two New Directional Ramps or Equivalent.
