# Access Compliance Report

## Public Rights-of-Way

### (Curb Ramps)

| Intersection ID: 50316 | Main Street: ESMERALDA_DR | Cross Street: STATESVILLE_RD | Location: NW |

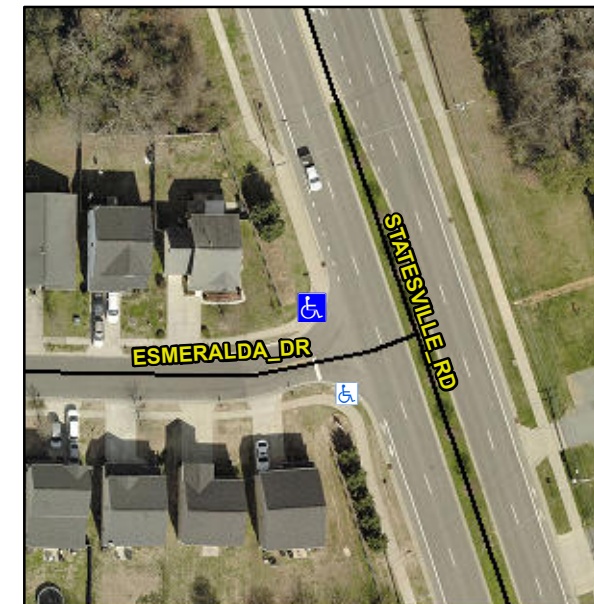
**LT RP < 5%**

**R304.3.2, R304.5.3**

| Compliance | Description | Data | Compliance | Description | Data |
|---|---|---|---|---|---|
| Yes | Ramp Slope LT (%) | 3.3 | No | Ramp Slope RT (%) | 10.3 |
| Yes | Ramp XSlope LT (%) | 1.4 | No | Ramp XSlope RT (%) | 2.1 |

**Remove & Replace Entire Ramp.**
