# Access Compliance Report

## Public Rights-of-Way

### (Curb Ramps)

Intersection ID: 7091	Main Street: BROOKSHIRE_BV	Cross Street: HOVIS_RD	Location:	E
ADA ID: D4F87A008E41	Ramp Type: Perp	Initial Pass/Fail: Fail	Overall Compliance: No	Severity Score: 8.75
Codes/Mitigation Info/Possible Solution		Field Measurements/Component Compliance

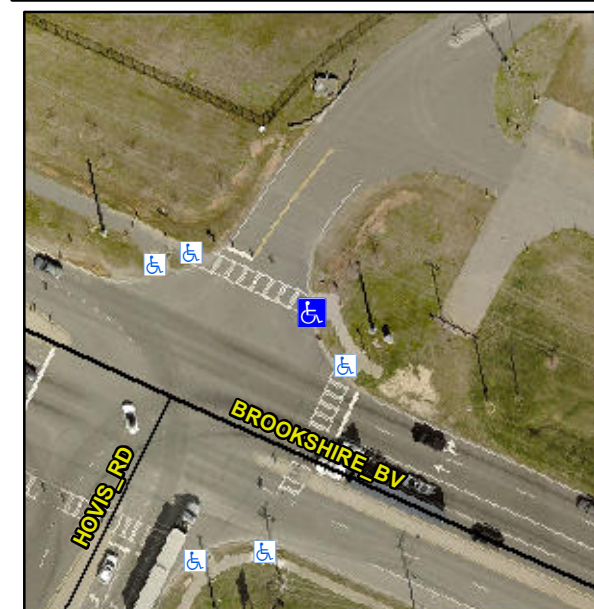
Compliance	Description	Data	Compliance	Description	Data
N/A	Ramp Length (in)	96.0	Yes	Ramp Slope (%)	6.6
No	Ramp Width (in)	40.5	Yes	Ramp XSlope (%)	1.0
N/A	Flare Type LT	N/A	N/A	Flare Type RT	N/A
N/A	Flare Slope LT (%)	N/A	N/A	Flare Slope RT (%)	N/A
N/A	Flare Traversable LT?	N/A	N/A	Flare Traversable RT?	N/A
N/A	Landing Length (in)	N/A	N/A	DWS Provided?	N/A
N/A	Landing Width (in)	N/A	N/A	DWS Contrast?	N/A
N/A	Landing Slope (%)	N/A	N/A	DWS Length (in)	N/A
N/A	Landing X Slope (%)	N/A	N/A	DWS Full Width?	N/A
N/A	Landing Curb? (Y/N)	N/A	N/A	DWS Offset (in)	N/A
N/A	Shared Landing?	N/A			
N/A	Gutter Ponding?	N/A	N/A	Gutter Slope (%)	N/A
N/A	Gutter Lip Ht (in)	N/A	N/A	Gutter X Slope (%)	N/A
N/A	Painted X Walk1?	Yes	N/A	Painted X Walk2?	N/A
	X Walk 1 Direction	To NW		X Walk 2 Direction	N/A
N/A	X Walk 1 Width (in)	113.0	N/A	X Walk 2 Width (in)	N/A
	X Walk 1 Slope (%)	1.7		X Walk 2 Slope (%)	N/A
	X Walk 1 X Slope (%)	1.9		X Walk 2 X Slope (%)	N/A

N/A	Ramp inside XWalk1?	Yes	N/A	Ramp inside XWalk2?	N/A
	Road Slope (%)	N/A	N/A	Clear Space?	N/A
	Road X Slope (%)	N/A	N/A	Clear Space to XWalk (in)	N/A
N/A	Any Obstructions?	N/A	N/A	Storm Grate/Utility Hazard?	N/A
	Obstruction Type			Storm Grate/Utility Type	
		N/A			N/A
		Yes		Surface Condition? (G/P)	Good

**Remove & Replace Entire Ramp.**

**R304.5.1**

Total Cost: \$ 1850.00
