Access Compliance Report

Public Rights-of-Way

(Curb Ramps)

Intersection ID: 10025333	Main Street: E_6TH_ST	Cross Street: N/A	Location: E
ADA ID: D522CF89321B	Ramp Type: Perp	Initial Pass/Fail: Pass	Overall Compliance: No
Severity Score: 0			
Codes/Mitigation Info/Possible Solution		Field Measurements/Component Compliance

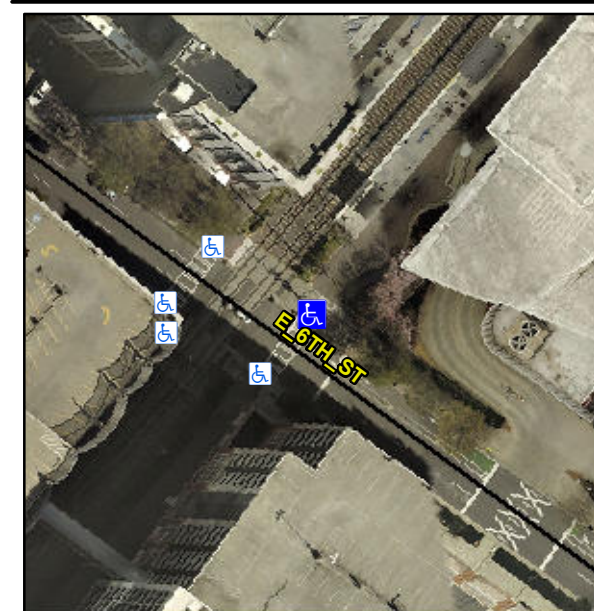
Compliance	Description	Data	Compliance	Description	Data
N/A	Ramp Length (in)	72.0	Yes	Ramp Slope (%)	6.6
Yes	Ramp Width (in)	48.0	Yes	Ramp XSlope (%)	0.0
N/A	Flare Type LT	Sloped	N/A	Flare Type RT	N/A
N/A	Flare Slope LT (%)	3.7	Yes	Flare Slope RT (%)	3.9
N/A	Flare Traversable LT?	Yes	N/A	Flare Traversable RT?	Yes
Yes	Landing Length (in)	48.0	Yes	DWS Provided?	Yes
Yes	Landing Width (in)	48.0	Yes	DWS Contrast?	Yes
No	Landing Slope (%)	2.7	Yes	DWS Length (in)	24.0
Yes	Landing X Slope (%)	1.9	Yes	DWS Full Width?	Yes
N/A	Landing Curb? (Y/N)	No	No	DWS Offset (in)	4.0
N/A	Shared Landing?	No			
Yes	Gutter Ponding?	No	Yes	Gutter Slope (%)	1.8
Yes	Gutter Lip Ht (in)	0.0	Yes	Gutter X Slope (%)	1.6
N/A	Painted X Walk1?	Yes	N/A	Painted X Walk2?	N/A
	X Walk 1 Direction	To SW		X Walk 2 Direction	N/A
N/A	X Walk 1 Width (in)	109.0	N/A	X Walk 2 Width (in)	N/A
	X Walk 1 Slope (%)	0.9		X Walk 2 Slope (%)	N/A
	X Walk 1 X Slope (%)	0.6		X Walk 2 X Slope (%)	N/A

Yes	Ramp inside XWalk1?	Yes	N/A	Ramp inside XWalk2?	N/A
	Road Slope (%)	N/A	N/A	Clear Space?	Yes
	Road X Slope (%)	N/A	N/A	Clear Space to XWalk (in)	N/A
Yes	Any Obstructions?	No	Yes	Storm Grate/Utility Hazard?	No
	Obstruction Type			Storm Grate/Utility Type	
		N/A			N/A
			Yes	Surface Condition? (G/P)	Good

Possible Solutions:

Remove & Replace Entire Ramp.

Not Found, R304.2.2-Perp, R304.3.2-Para, R305.2

Total Cost: \$ 1850.00
