# Access Compliance Report

## Public Rights-of-Way

### (Curb Ramps)

Intersection ID: 12728	Main Street: E_10TH_ST	Cross Street: SEIGLE_AV	Location:	N
ADA ID: D523143B8ADA	Ramp Type: BlendTrans1	Initial Pass/Fail: Pass	Overall Compliance: No	Severity Score: 0.25
Codes/Mitigation Info/Possible Solution		Field Measurements/Component Compliance

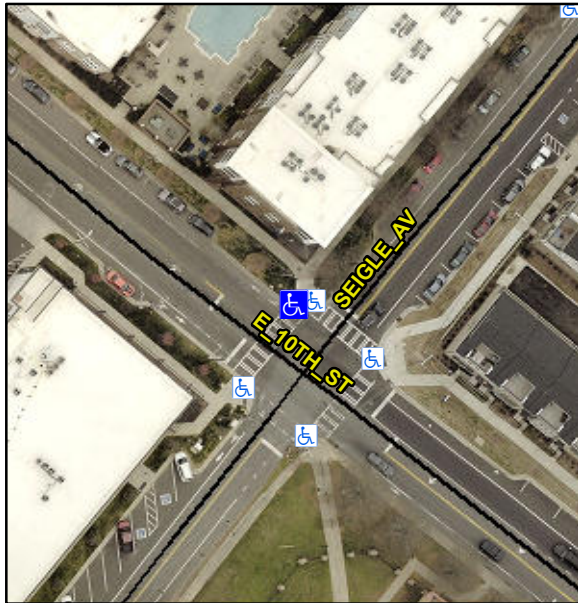
**Not Found, R304.5.3, R305.2**

Compliance	Description	Data	Compliance	Description	Data
N/A	Ramp Length (in)	79.0	Yes	BlendTrans Slope (%)	2.5
Yes	Ramp Width (in)	65.0	No	BlendTrans XSlope (%)	5.0
N/A	Flare Type LT	None	N/A	Flare Type RT	None
N/A	Flare Slope LT (%)	N/A	N/A	Flare Slope RT (%)	N/A
N/A	Flare Traversable LT?	N/A	N/A	Flare Traversable RT?	N/A
Yes	Landing Length (in)	60.0	Yes	DWS Provided?	Yes
Yes	Landing Width (in)	61.0	Yes	DWS Contrast?	Yes
Yes	Landing Slope (%)	1.5	Yes	DWS Length (in)	24.0
Yes	Landing X Slope (%)	1.3	Yes	DWS Full Width?	Yes
N/A	Landing Curb? (Y/N)	No	No	DWS Offset (in)	7.0
N/A	Shared Landing?	Yes			
Yes	Gutter Ponding?	No	Yes	Gutter Slope (%)	0.3
Yes	Gutter Lip Ht (in)	0.0	No	Gutter X Slope (%)	6.2
N/A	Painted X Walk1?	Yes	N/A	Painted X Walk2?	N/A
	X Walk 1 Direction	To SW		X Walk 2 Direction	N/A
	X Walk 1 Width (in)	90.0		X Walk 2 Width (in)	N/A
	X Walk 1 Slope (%)	2.7		X Walk 2 Slope (%)	N/A
	X Walk 1 X Slope (%)	1.3		X Walk 2 X Slope (%)	N/A

Yes	Ramp inside XWalk1?	Yes	N/A	Ramp inside XWalk2?	N/A
	Road Slope (%)	1.3		Clear Space?	Yes
	Road X Slope (%)	2.7	N/A	Clear Space to XWalk (in)	N/A
Yes	Any Obstructions?	No	Yes	Storm Grate/Utility Hazard?	No
	Obstruction Type			Storm Grate/Utility Type	
		N/A			N/A
			Yes	Surface Condition? (G/P)	Good
			No	Curb Slope (%)	15.9

**Remove & Replace Curb Ramp With Two New Directional Ramps or Equivalent. Remove & Replace Gutter.**
