Access Compliance Report

Public Rights-of-Way

(Curb Ramps)

Intersection ID: 30006	Main Street: FULLERTON_CT	Cross Street: OAKBORO_LN	Location: SW
ADA ID: D5234B74B635	Ramp Type: BlendTrans2	Initial Pass/Fail: Fail	Overall Compliance: No
Codes/Mitigation Info/Possible Solution		Field Measurements/Component Compliance	
Severity Score: 8.75

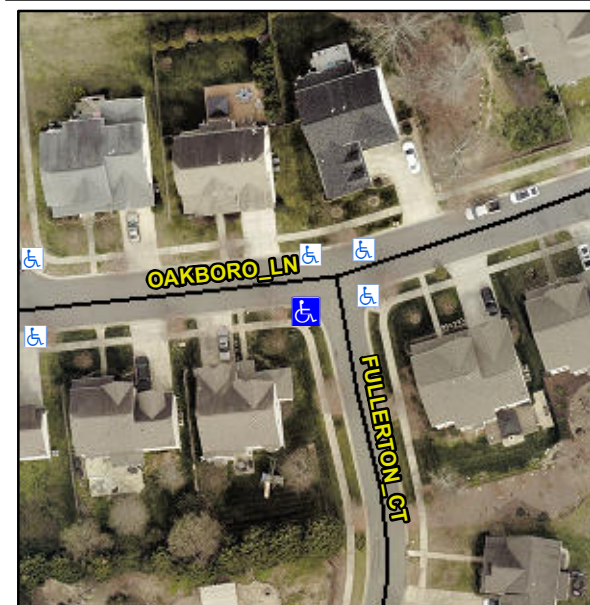
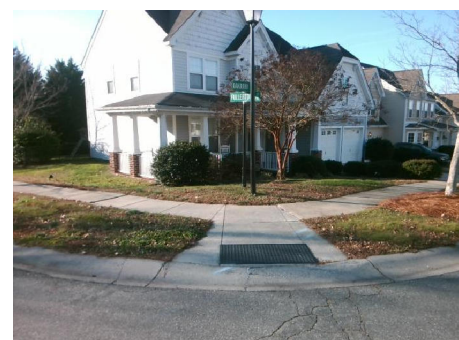
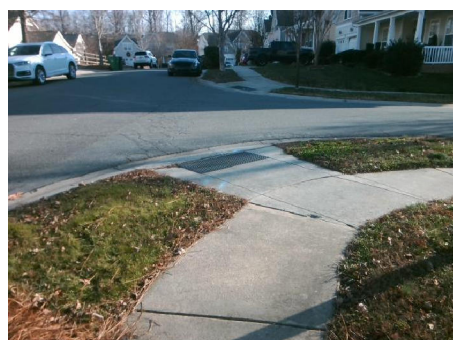
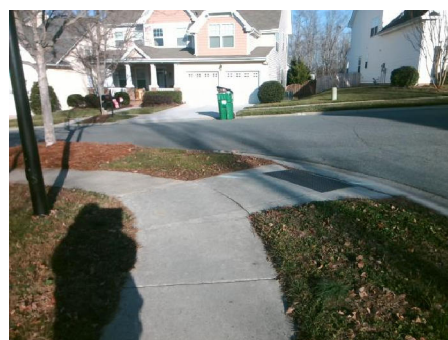
Not Found, R304.5.1

Compliance	Description	Data	Compliance	Description	Data
N/A	Ramp Length (in)	117.0	Yes	BlendTrans Slope (%)	2.5
No	Ramp Width (in)	43.0	Yes	BlendTrans XSlope (%)	0.1
N/A	Flare Type LT	N/A	N/A	Flare Type RT	N/A
N/A	Flare Slope LT (%)	N/A	N/A	Flare Slope RT (%)	N/A
N/A	Flare Traversable LT?	N/A	N/A	Flare Traversable RT?	N/A
N/A	Landing Length (in)	N/A	N/A	DWS Provided?	N/A
N/A	Landing Width (in)	N/A	N/A	DWS Contrast?	N/A
N/A	Landing Slope (%)	N/A	N/A	DWS Length (in)	N/A
N/A	Landing X Slope (%)	N/A	N/A	DWS Full Width?	N/A
N/A	Landing Curb? (Y/N)	N/A	N/A	DWS Offset (in)	N/A
N/A	Shared Landing?	N/A			
N/A	Gutter Ponding?	N/A	N/A	Gutter Slope (%)	N/A
N/A	Gutter Lip Ht (in)	N/A	N/A	Gutter X Slope (%)	N/A
N/A	Painted X Walk1?	No	N/A	Painted X Walk2?	No
	X Walk 1 Direction	To E		X Walk 2 Direction	To N
	X Walk 1 Width (in)	N/A		X Walk 2 Width (in)	N/A
	X Walk 1 Slope (%)	3.8		X Walk 2 Slope (%)	4.6
	X Walk 1 X Slope (%)	3.2		X Walk 2 X Slope (%)	5.3

N/A	Ramp inside XWalk1?	N/A	N/A	Ramp inside XWalk2?	N/A
	Road Slope (%)	2.7		Clear Space?	N/A
	Road X Slope (%)	8.4	N/A	Clear Space to XWalk (in)	N/A
N/A	Any Obstructions?	N/A	N/A	Storm Grate/Utility Hazard?	N/A
	Obstruction Type			Storm Grate/Utility Type	
		N/A			N/A
			Yes	Surface Condition? (G/P)	Good
			No	Curb Slope (%)	17.3

Remove & Replace Curb Ramp With Two New Directional Ramps or Equivalent.

Total Cost: \$ 3200.00
