Access Compliance Report

Public Rights-of-Way (Curb Ramps)

Intersection ID: 45694	Main Street: E_ARROWWOOD_RD	Cross Street: SILVER_ARROW_DR	Location: SW
ADA ID: D52572D75A75	Ramp Type: PerpDiag	Initial Pass/Fail: Fail	Overall Compliance: No Severity Score: 58.75

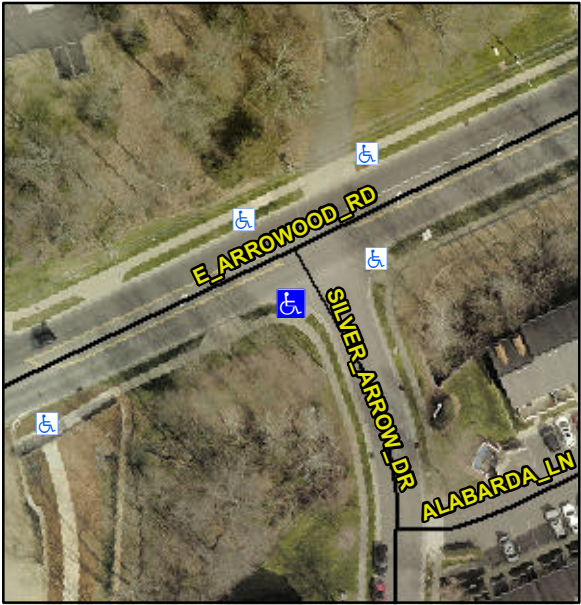
Possible Solutions:				
	Remove & Replace Curb Ramp With Two New Directional Ramps or Equivalent.				
	Surveyor Notes:				
	N/A				
	PROW/ADA:				
	R304.5.1, R304.2.2, R304.5.3				
	Street 1 Name	SILVER ARROW DR			
	Stop Condition-Street 2	StopSign			
	Street 2 Name	E ARROWOOD RD			
	Stop Condition-Street 1	None			
Total Cost:		\$	3200.00		
Compliance	Description	Data	Compliance	Description	Data
N/A	Ramp Length (in)	59.5	No	Ramp Slope (%)	12.2
No	Ramp Width (in)	42.0	No	Ramp XSlope (%)	12.3
N/A	Flare Type LT	N/A	N/A	Flare Type RT	N/A
N/A	Flare Slope LT (%)	N/A	N/A	Flare Slope RT (%)	N/A
N/A	Flare Traversable LT?	N/A	N/A	Flare Traversable RT?	N/A
N/A	Landing Length (in)	N/A	N/A	DWS Provided?	N/A
N/A	Landing Width (in)	N/A	N/A	DWS Contrast?	N/A
N/A	Landing Slope (%)	N/A	N/A	DWS Length (in)	N/A
N/A	Landing X Slope (%)	N/A	N/A	DWS Full Width?	N/A

N/A	Landing Curb? (Y/N)	N/A	N/A	DWS Offset (in)	N/A
N/A	Shared Landing?	N/A			
N/A	Gutter Ponding?	N/A	N/A	Gutter Slope (%)	N/A
N/A	Gutter Lip Ht (in)	N/A	N/A	Gutter X Slope (%)	N/A
N/A	Painted X Walk1?	No	N/A	Painted X Walk2?	No
	X Walk 1 Direction	To NE		X Walk 2 Direction	To N
N/A	X Walk 1 Width (in)	N/A	N/A	X Walk 2 Width (in)	N/A
	X Walk 1 Slope (%)	6.2		X Walk 2 Slope (%)	9.0
	X Walk 1 X Slope (%)	10.3		X Walk 2 X Slope (%)	5.8
N/A	Ramp inside XWalk1?	N/A	N/A	Ramp inside XWalk2?	N/A
	Road Slope (%)	11.2	N/A	Clear Space?	N/A
	Road X Slope (%)	1.1	N/A	Clear Space to XWalk (in)	N/A
N/A	Any Obstructions?	N/A	N/A	Storm Grate/Utility Hazard?	N/A
	Obstruction Type			Storm Grate/Utility Type	
		N/A			N/A
			Yes	Surface Condition? (G/P)	Good
