# Access Compliance Report

## Public Rights-of-Way

### (Curb Ramps)

Intersection ID: 5497	Main Street: GRAYS_CREEK_LN	Cross Street: SOUTH_FORD_RD	Location: S
ADA ID: D525A7C57F21	Ramp Type: Perp	Initial Pass/Fail: Fail	Overall Compliance: No
Severity Score: 22.5			
Codes/Mitigation Info/Possible Solution		Field Measurements/Component Compliance

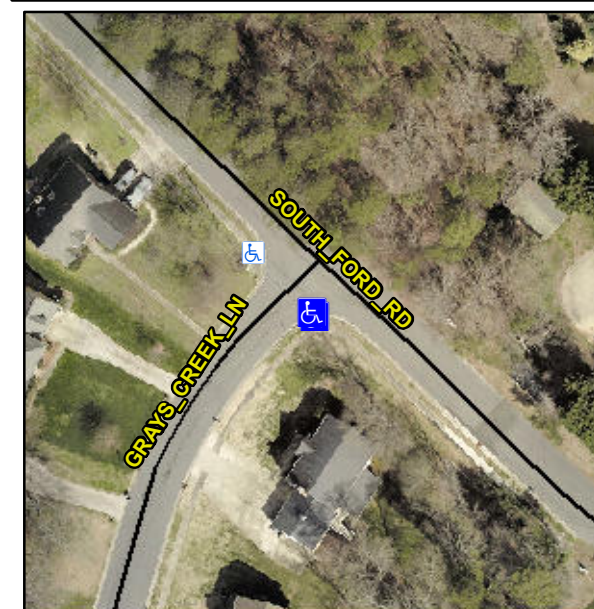
**Not Found, R304.5.1, R304.2.2, R304.5.3**

Compliance	Description	Data	Compliance	Description	Data
N/A	Ramp Length (in)	36.0	No	Ramp Slope (%)	8.5
No	Ramp Width (in)	46.0	No	Ramp XSlope (%)	3.3
N/A	Flare Type LT	N/A	N/A	Flare Type RT	N/A
N/A	Flare Slope LT (%)	N/A	N/A	Flare Slope RT (%)	N/A
N/A	Flare Traversable LT?	N/A	N/A	Flare Traversable RT?	N/A
N/A	Landing Length (in)	N/A	N/A	DWS Provided?	N/A
N/A	Landing Width (in)	N/A	N/A	DWS Contrast?	N/A
N/A	Landing Slope (%)	N/A	N/A	DWS Length (in)	N/A
N/A	Landing X Slope (%)	N/A	N/A	DWS Full Width?	N/A
N/A	Landing Curb? (Y/N)	N/A	N/A	DWS Offset (in)	N/A
N/A	Shared Landing?	N/A			
N/A	Gutter Ponding?	N/A	N/A	Gutter Slope (%)	N/A
N/A	Gutter Lip Ht (in)	N/A	N/A	Gutter X Slope (%)	N/A
N/A	Painted X Walk1?	No	N/A	Painted X Walk2?	N/A
	X Walk 1 Direction	To NW		X Walk 2 Direction	N/A
N/A	X Walk 1 Width (in)	N/A	N/A	X Walk 2 Width (in)	N/A
	X Walk 1 Slope (%)	2.1		X Walk 2 Slope (%)	N/A
	X Walk 1 X Slope (%)	3.8		X Walk 2 X Slope (%)	N/A

N/A	Ramp inside XWalk1?	N/A	N/A	Ramp inside XWalk2?	N/A
	Road Slope (%)	N/A	N/A	Clear Space?	N/A
	Road X Slope (%)	N/A	N/A	Clear Space to XWalk (in)	N/A
N/A	Any Obstructions?	N/A	N/A	Storm Grate/Utility Hazard?	N/A
	Obstruction Type			Storm Grate/Utility Type	
		N/A			N/A
			Yes	Surface Condition? (G/P)	Good

**Remove & Replace Entire Ramp.**

Total Cost: \$ 1850.00
