# Access Compliance Report

## Public Rights-of-Way

| Intersection ID: 30128 | Main Street: GALESBURG_ST | Cross Street: WADENA_DR | Location: NE |
| ADA ID: D526AD880490 | Ramp Type: PerpDiag | Initial Pass/Fail: Fail | Overall Compliance: No |

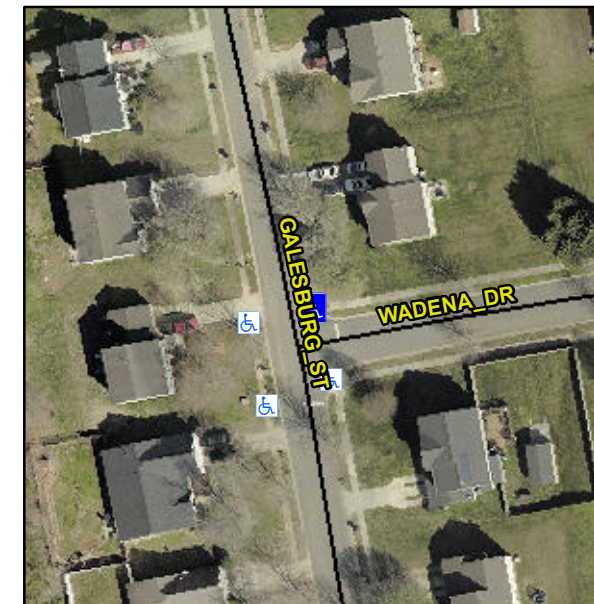
| | | Severity Score: 1.25 | |

**Not Found, R304.5.3**

| Compliance | Description | Data | Compliance | Description | Data |
|---|---|---|---|---|---|
| N/A | Ramp Length (in) | 95.0 | Yes | Ramp Slope (%) | 5.7 |
| Yes | Ramp Width (in) | 48.0 | No | Ramp XSlope (%) | 3.0 |

**Remove & Replace Curb Ramp With Two New Directional Ramps or Equivalent.**

Total Cost: \$ 3200.00
