Access Compliance Report Public Rights-of-Way (Curb Ramps)

Intersection ID: 27507 Main Street: BALLANTYNE MEADOWS DR Cross Street: WILLOW MEADOW LN Location: N

ADA ID: D5276216DDCB Ramp Type: PerpDiag Initial Pass/Fail: Fail **Overall Compliance: No Severity Score:** 37.5

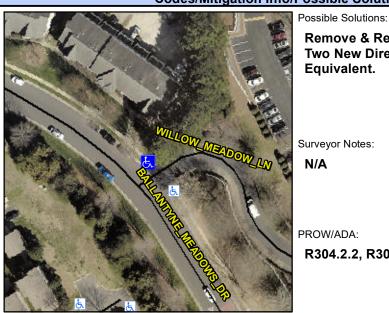
Compliance Description		Data	Comp	liance	Description	Data
N/A	Ramp Length (in)	52.0	No	Ramp	Slope (%)	9.9
Yes	Ramp Width (in)	48.0	No	Ramp	XSlope (%)	7.0
N/A	Flare Type LT	N/A	N/A	Flare	Type RT	N/A
N/A	Flare Slope LT (%)	N/A	N/A	Flare	Slope RT (%)	N/A
N/A	Flare Traversable LT?	N/A	N/A	Flare	Traversable RT?	N/A
N/A	Landing Length (in)	N/A	N/A	DWS	Provided?	N/A
N/A	Landing Width (in)	N/A	N/A	DWS	Contrast?	N/A
N/A	Landing Slope (%)	N/A	N/A	DWS	Length (in)	N/A
N/A	Landing X Slope (%)	N/A	N/A	DWS	Full Width?	N/A
N/A	Landing Curb? (Y/N)	N/A	N/A	DWS	Offset (in)	N/A
N/A	Shared Landing?	N/A				
N/A	Gutter Ponding?	N/A	N/A	Gutte	Slope (%)	N/A
N/A	Gutter Lip Ht (in)	N/A	N/A	Gutte	X Slope (%)	N/A
N/A	Painted X Walk1?	No	N/A	Painte	ed X Walk2?	No
	X Walk 1 Direction	To W		X Wal	k 2 Direction	To SE
N/A	X Walk 1 Width (in)	N/A	N/A	X Wal	k 2 Width (in)	N/A
	X Walk 1 Slope (%)	3.0		X Wal	k 2 Slope (%)	1.9
	X Walk 1 X Slope (%)	1.3		X Wal	k 2 X Slope (%)	3.6

N/A	Ramp inside XWalk1?	N/A	N/A	Ramp	inside XWalk2?	N/A
	Road Slope (%)	2.6	N/A	Clear	Space?	N/A
	Road X Slope (%)	0.0	N/A	Clear	Space to XWalk (in)	N/A
N/A	Any Obstructions?	N/A	N/A	Storm	Grate/Utility Hazard?	N/A
	Obstruction Type			Storm	Grate/Utility Type	
		N/A				N/A
			l

BALLANTYNE MEADOWS DR Street 1 Name Stop Condition-Street 2 None Street 2 Name **WILLOW MEADOW LN** Stop Condition-Street 1 StopSign Remove & Replace Curb Ramp With Two New Directional Ramps or Equivalent.

R304.2.2, R304.5.3

3200.00
