Access Compliance Report

Public Rights-of-Way

(Curb Ramps)

Intersection ID: 28390	Main Street: ARDREY_KELL_RD	Cross Street: BRIDGEHAMPTON_CLUB_DR	Location: E
ADA ID: D52D83DC9C68	Ramp Type: BlendTrans1	Initial Pass/Fail: Fail	Overall Compliance: No
			Severity Score: 33.75

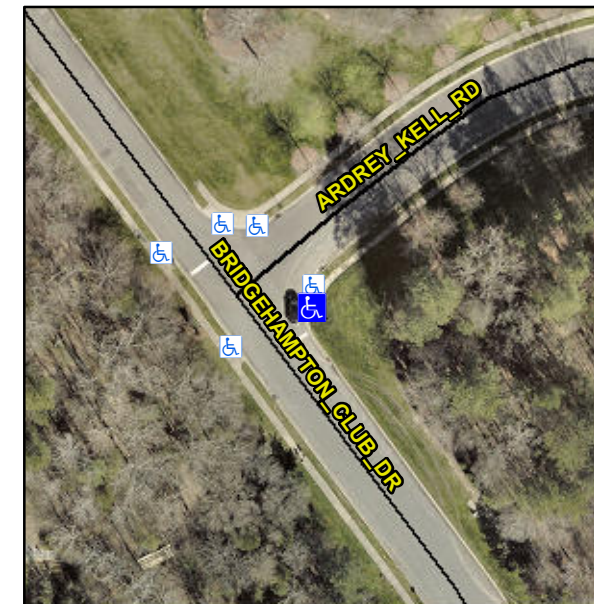
Not Found, R304.5.1, R304.5.3

Compliance	Description	Data	Compliance	Description	Data
N/A	Ramp Length (in)	47.5	Yes	BlendTrans Slope (%)	3.0
No	Ramp Width (in)	40.0	No	BlendTrans XSlope (%)	7.4
N/A	Flare Type LT	N/A	N/A	Flare Type RT	N/A
N/A	Flare Slope LT (%)	N/A	N/A	Flare Slope RT (%)	N/A
N/A	Flare Traversable LT?	N/A	N/A	Flare Traversable RT?	N/A
N/A	Landing Length (in)	N/A	N/A	DWS Provided?	N/A
N/A	Landing Width (in)	N/A	N/A	DWS Contrast?	N/A
N/A	Landing Slope (%)	N/A	N/A	DWS Length (in)	N/A
N/A	Landing X Slope (%)	N/A	N/A	DWS Full Width?	N/A
N/A	Landing Curb? (Y/N)	N/A	N/A	DWS Offset (in)	N/A
N/A	Shared Landing?	N/A			
N/A	Gutter Ponding?	N/A	N/A	Gutter Slope (%)	N/A
N/A	Gutter Lip Ht (in)	N/A	N/A	Gutter X Slope (%)	N/A
N/A	Painted X Walk1?	No	N/A	Painted X Walk2?	N/A
	X Walk 1 Direction	To SW		X Walk 2 Direction	N/A
	X Walk 1 Width (in)	N/A		X Walk 2 Width (in)	N/A
	X Walk 1 Slope (%)	3.3		X Walk 2 Slope (%)	N/A
	X Walk 1 X Slope (%)	3.3		X Walk 2 X Slope (%)	N/A

N/A	Ramp inside XWalk1?	N/A	N/A	Ramp inside XWalk2?	N/A
	Road Slope (%)	3.3		Clear Space?	N/A
	Road X Slope (%)	3.3	N/A	Clear Space to XWalk (in)	N/A
N/A	Any Obstructions?	N/A	N/A	Storm Grate/Utility Hazard?	N/A
	Obstruction Type			Storm Grate/Utility Type	
		N/A			N/A
			Yes	Surface Condition? (G/P)	Good
			No	Curb Slope (%)	5.8

Remove & Replace Curb Ramp With Two New Directional Ramps or Equivalent.
