# Access Compliance Report

## Public Rights-of-Way

### (Curb Ramps)

| Intersection ID: N/A | Main Street: YORKMONT_RD | Cross Street: OAK_LAKE_BV | Location: NE |

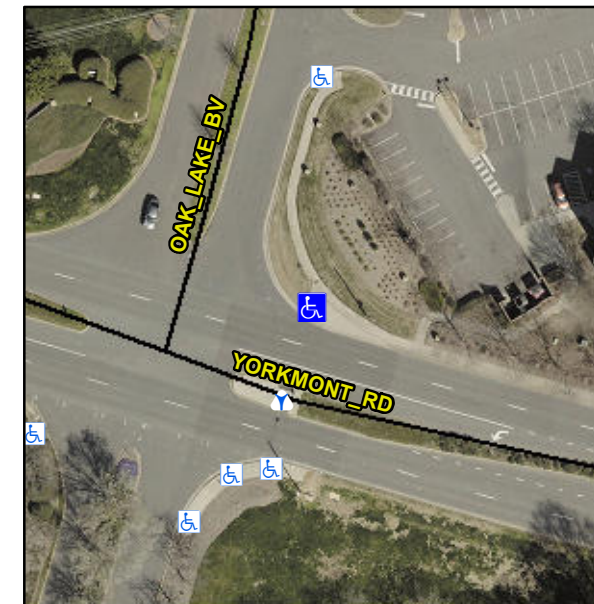
| ADA ID: D52DD53DB6A3 | Ramp Type: BlendTrans1 | Initial Pass/Fail: Pass | Overall Compliance: No |
| | | Severity Score: 2.75 | |

| Compliance | Description | Data | Compliance | Description | Data |
|---|---|---|---|---|---|
| No | Landing Slope (%) | 2.9 | Yes | DWS Length (in) | 24.5 |
| Yes | Landing X Slope (%) | 1.5 | No | DWS Full Width? | No |
| N/A | Landing Curb? (Y/N) | No | No | DWS Offset (in) | 2.5 |

Possible Solutions:

**Remove & Replace Curb Ramp With Two New Directional Ramps or Equivalent.**
