Access Compliance Report

Public Rights-of-Way

(Curb Ramps)

Intersection ID: 9447	Main Street: ATANDO_AV	Cross Street: N_TRYON_ST	Location: NW
ADA ID: D5304554D3D0	Ramp Type: Perp	Initial Pass/Fail: Fail	Overall Compliance: No
Severity Score: 22.5			
Codes/Mitigation Info/Possible Solution		Field Measurements/Component Compliance

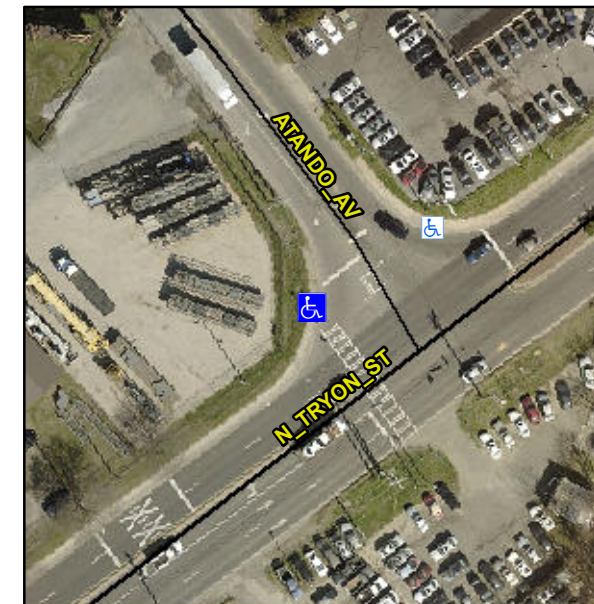
Not Found, R304.5.1, R304.2.2, R304.5.3

Compliance	Description	Data	Compliance	Description	Data
N/A	Ramp Length (in)	58.0	No	Ramp Slope (%)	9.1
No	Ramp Width (in)	42.5	No	Ramp XSlope (%)	4.7
N/A	Flare Type LT	N/A	N/A	Flare Type RT	N/A
N/A	Flare Slope LT (%)	N/A	N/A	Flare Slope RT (%)	N/A
N/A	Flare Traversable LT?	N/A	N/A	Flare Traversable RT?	N/A
N/A	Landing Length (in)	N/A	N/A	DWS Provided?	N/A
N/A	Landing Width (in)	N/A	N/A	DWS Contrast?	N/A
N/A	Landing Slope (%)	N/A	N/A	DWS Length (in)	N/A
N/A	Landing X Slope (%)	N/A	N/A	DWS Full Width?	N/A
N/A	Landing Curb? (Y/N)	N/A	N/A	DWS Offset (in)	N/A
N/A	Shared Landing?	N/A			
N/A	Gutter Ponding?	N/A	N/A	Gutter Slope (%)	N/A
N/A	Gutter Lip Ht (in)	0.5	N/A	Gutter X Slope (%)	N/A
N/A	Painted X Walk1?	Yes	N/A	Painted X Walk2?	N/A
	X Walk 1 Direction	To NE		X Walk 2 Direction	N/A
N/A	X Walk 1 Width (in)	114.5	N/A	X Walk 2 Width (in)	N/A
	X Walk 1 Slope (%)	0.3		X Walk 2 Slope (%)	N/A
	X Walk 1 X Slope (%)	4.0		X Walk 2 X Slope (%)	N/A

N/A	Ramp inside XWalk1?	Yes	N/A	Ramp inside XWalk2?	N/A
	Road Slope (%)	N/A	N/A	Clear Space?	N/A
	Road X Slope (%)	N/A	N/A	Clear Space to XWalk (in)	N/A
N/A	Any Obstructions?	N/A	N/A	Storm Grate/Utility Hazard?	N/A
	Obstruction Type			Storm Grate/Utility Type	
		N/A			N/A
		Yes		Surface Condition? (G/P)	Good

Remove & Replace Entire Ramp.
