# Access Compliance Report

## Public Rights-of-Way

| Intersection ID: 15965 | Main Street: CLAYTON_DR | Cross Street: CUMBERLAND_AV | Location: NW |
| ADA ID: D530C65DC5DA | Ramp Type: PerpDiag | Initial Pass/Fail: Fail | Overall Compliance: No |

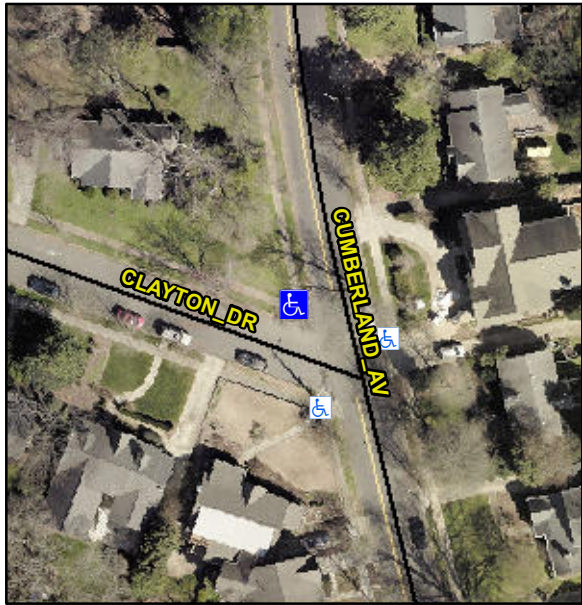
| | | | Severity Score: 21.25 |

| Codes/Mitigation Info/Possible Solution | | | Field Measurements/Component Compliance | | | | | |
|---|---|---|---|---|---|---|---|---|
| | Remove & Replace Curb Ramp With Two New Directional Ramps or Equivalent. | | N/A | Ramp Length (in) | 58.0 | No | Ramp Slope (%) | 11.3 |
| | | | No | Ramp Width (in) | 46.0 | Yes | Ramp XSlope (%) | 0.7 |
| PROW/ADA: | | | N/A | Gutter Ponding? | Yes | N/A | Gutter Slope (%) | N/A |
| Not Found, R304.5.1, R304.2.2 | | | N/A | Gutter Lip Ht (in) | N/A | N/A | Gutter X Slope (%) | N/A |

| Codes/Mitigation Info/Possible Solution | | | Field Measurements/Component Compliance | | | | | |
|---|---|---|---|---|---|---|---|---|
| | Possible Solutions: | | Compliance | Description | Data | Compliance | Description | Data |
| Total Cost: | | \$ 3200.00 | | | | | | |
