# Access Compliance Report

## Public Rights-of-Way

### (Curb Ramps)

Intersection ID: 30340	Main Street: DULIN_CREEK_BV	Cross Street: FOX_SWAMP_RD	Location: NE
ADA ID: D53C3682AF14	Ramp Type: PerpDiag	Initial Pass/Fail: Fail	Overall Compliance: No
Severity Score: 8.75			
Codes/Mitigation Info/Possible Solution		Field Measurements/Component Compliance

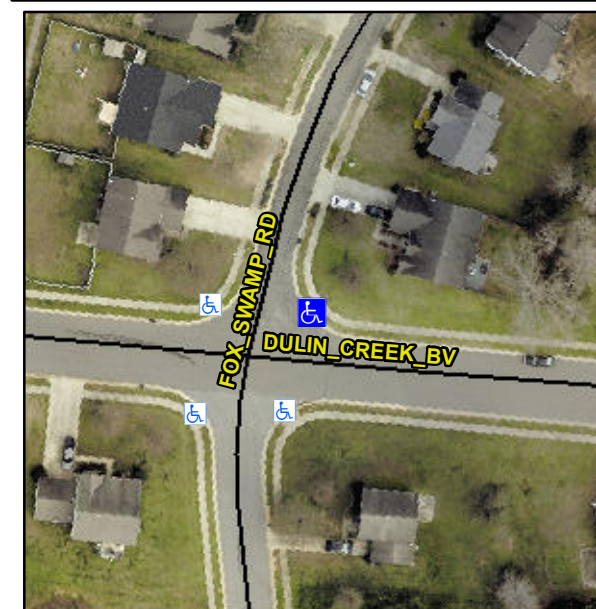
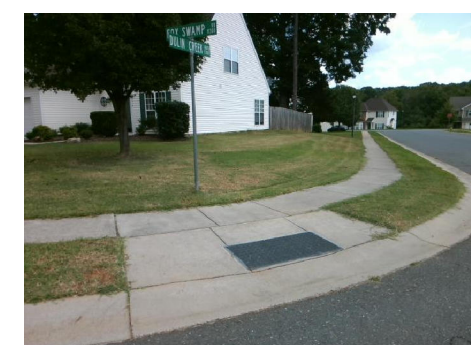
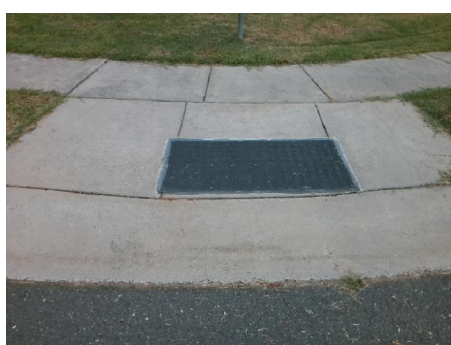
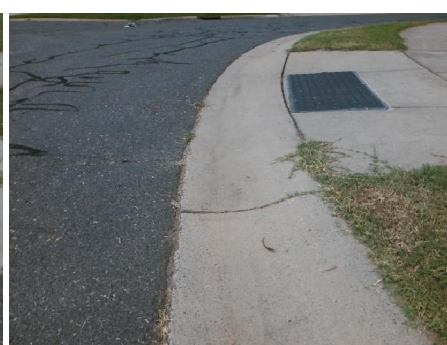
Compliance	Description	Data	Compliance	Description	Data
N/A	Ramp Length (in)	51.0	Yes	Ramp Slope (%)	7.2
No	Ramp Width (in)	45.0	Yes	Ramp XSlope (%)	1.9
N/A	Flare Type LT	N/A	N/A	Flare Type RT	N/A
N/A	Flare Slope LT (%)	N/A	N/A	Flare Slope RT (%)	N/A
N/A	Flare Traversable LT?	N/A	N/A	Flare Traversable RT?	N/A
N/A	Landing Length (in)	N/A	N/A	DWS Provided?	N/A
N/A	Landing Width (in)	N/A	N/A	DWS Contrast?	N/A
N/A	Landing Slope (%)	N/A	N/A	DWS Length (in)	N/A
N/A	Landing X Slope (%)	N/A	N/A	DWS Full Width?	N/A
N/A	Landing Curb? (Y/N)	N/A	N/A	DWS Offset (in)	N/A
N/A	Shared Landing?	N/A			
N/A	Gutter Ponding?	N/A	N/A	Gutter Slope (%)	N/A
N/A	Gutter Lip Ht (in)	N/A	N/A	Gutter X Slope (%)	N/A
N/A	Painted X Walk1?	No	N/A	Painted X Walk2?	No
	X Walk 1 Direction	To W		X Walk 2 Direction	To S
N/A	X Walk 1 Width (in)	N/A	N/A	X Walk 2 Width (in)	N/A
	X Walk 1 Slope (%)	1.7		X Walk 2 Slope (%)	0.8
	X Walk 1 X Slope (%)	2.1		X Walk 2 X Slope (%)	0.4

N/A	Ramp inside XWalk1?	N/A	N/A	Ramp inside XWalk2?	N/A
	Road Slope (%)	1.6	N/A	Clear Space?	N/A
	Road X Slope (%)	1.3	N/A	Clear Space to XWalk (in)	N/A
N/A	Any Obstructions?	N/A	N/A	Storm Grate/Utility Hazard?	N/A
	Obstruction Type			Storm Grate/Utility Type	
		N/A			N/A
			Yes	Surface Condition? (G/P)	Good

**Remove & Replace Curb Ramp With Two New Directional Ramps or Equivalent.**

**R304.5.1**
