## **Access Compliance Report Public Rights-of-Way** (Curb Ramps)

Intersection ID: N/A Main Street: TYVOLA RD **Cross Street: SPEER BV** Location:

Initial Pass/Fail: Fail **Overall Compliance: No** ADA ID: D5420D4D9200 Ramp Type: Perp Severity Score: 13.75

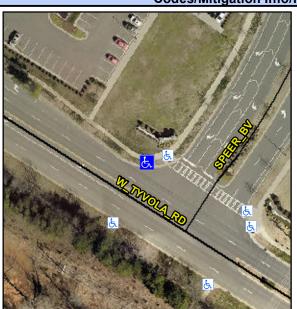
**TYVOLA RD** Street 1 Name Stop Condition-Street 2 None N/A Street 2 Name Stop Condition-Street 1 N/A Possible Solutions: Compliance Description Remove & Replace Entire Ramp. Surveyor Notes: N/A PROW/ADA: Not Found, R304.2.2, R304.5.3

No Ramp Slope (%) N/A Ramp Length (in) 71.0 9.9 70.0 No Ramp XSlope (%) Yes Ramp Width (in) 3.8 N/A N/A Flare Type LT N/A Flare Type RT N/A N/A N/A N/A Flare Slope RT (%) N/A Flare Slope LT (%) N/A Flare Traversable LT? N/A N/A Flare Traversable RT? N/A N/A N/A N/A **DWS Provided?** N/A Landing Length (in) N/A Landing Width (in) N/A N/A **DWS Contrast?** N/A N/A N/A N/A Landing Slope (%) DWS Length (in) N/A N/A Landing X Slope (%) N/A N/A DWS Full Width? N/A N/A Landing Curb? (Y/N) N/A N/A DWS Offset (in) N/A N/A N/A Shared Landing? N/A **Gutter Ponding?** N/A N/A Gutter Slope (%) N/A N/A Gutter Lip Ht (in) N/A N/A Gutter X Slope (%) N/A N/A Painted X Walk1? No N/A Painted X Walk2? N/A X Walk 1 Direction To SW X Walk 2 Direction N/A N/A N/A X Walk 1 Width (in) X Walk 2 Width (in) N/A X Walk 1 Slope (%) 6.2 X Walk 2 Slope (%) N/A X Walk 1 X Slope (%) 0.9 X Walk 2 X Slope (%) N/A N/A N/A N/A Ramp inside XWalk2? Ramp inside XWalk1? N/A Road Slope (%) N/A N/A Clear Space? N/A N/A Road X Slope (%) N/A Clear Space to XWalk (in) N/A N/A N/A Any Obstructions? N/A Storm Grate/Utility Hazard? N/A **Obstruction Type** Storm Grate/Utility Type N/A N/A Yes Surface Condition? (G/P) Good
