# Access Compliance Report

## Public Rights-of-Way

### (Curb Ramps)

Intersection ID: 10759	Main Street: SPRATT_ST	Cross Street: OLIVER_ST	Location: NE
ADA ID: D54BBD7FDA77	Ramp Type: Perp	Initial Pass/Fail: Fail	Overall Compliance: No
		Severity Score: 8.75	
Codes/Mitigation Info/Possible Solution		Field Measurements/Component Compliance

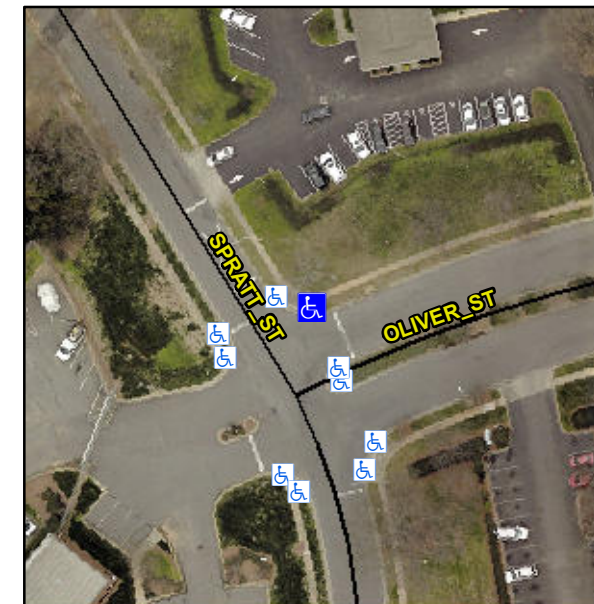
Compliance	Description	Data	Compliance	Description	Data
N/A	Ramp Length (in)	114.5	Yes	Ramp Slope (%)	6.5
No	Ramp Width (in)	41.0	Yes	Ramp XSlope (%)	1.0
N/A	Flare Type LT	N/A	N/A	Flare Type RT	N/A
N/A	Flare Slope LT (%)	N/A	N/A	Flare Slope RT (%)	N/A
N/A	Flare Traversable LT?	N/A	N/A	Flare Traversable RT?	N/A
N/A	Landing Length (in)	N/A	N/A	DWS Provided?	N/A
N/A	Landing Width (in)	N/A	N/A	DWS Contrast?	N/A
N/A	Landing Slope (%)	N/A	N/A	DWS Length (in)	N/A
N/A	Landing X Slope (%)	N/A	N/A	DWS Full Width?	N/A
N/A	Landing Curb? (Y/N)	N/A	N/A	DWS Offset (in)	N/A
N/A	Shared Landing?	N/A			
N/A	Gutter Ponding?	N/A	N/A	Gutter Slope (%)	N/A
N/A	Gutter Lip Ht (in)	1.5	N/A	Gutter X Slope (%)	N/A
N/A	Painted X Walk1?	No	N/A	Painted X Walk2?	N/A
	X Walk 1 Direction	To S		X Walk 2 Direction	N/A
N/A	X Walk 1 Width (in)	N/A	N/A	X Walk 2 Width (in)	N/A
	X Walk 1 Slope (%)	4.2		X Walk 2 Slope (%)	N/A
	X Walk 1 X Slope (%)	1.2		X Walk 2 X Slope (%)	N/A

N/A	Ramp inside XWalk1?	N/A	N/A	Ramp inside XWalk2?	N/A
	Road Slope (%)	N/A	N/A	Clear Space?	N/A
	Road X Slope (%)	N/A	N/A	Clear Space to XWalk (in)	N/A
N/A	Any Obstructions?	N/A	N/A	Storm Grate/Utility Hazard?	N/A
	Obstruction Type			Storm Grate/Utility Type	
		N/A			N/A
			Yes	Surface Condition? (G/P)	Good

**Remove & Replace Entire Ramp.**

**Not Found, R304.5.1**
