Access Compliance Report

Public Rights-of-Way

(Curb Ramps)

Intersection ID: 46698	Main Street: COFFEEBERRY_LN	Cross Street: TROTTERS_RIDGE_RD	Location: NW
ADA ID: D54C27E15E31	Ramp Type: PerpDiag	Initial Pass/Fail: Fail	Overall Compliance: No
Severity Score: 21.25			
Codes/Mitigation Info/Possible Solution		Field Measurements/Component Compliance

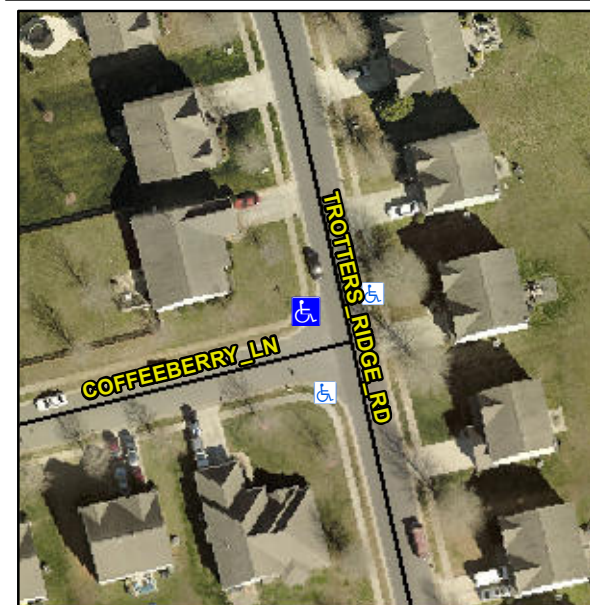
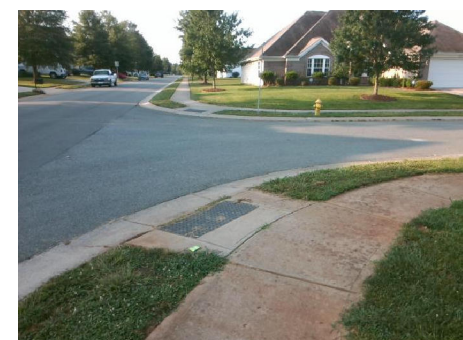
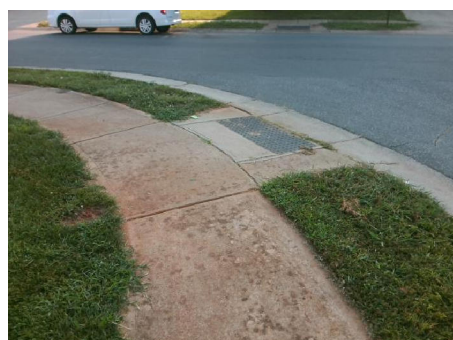
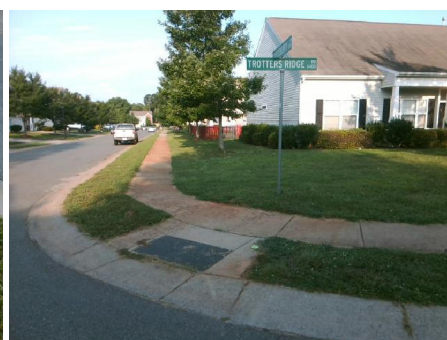
Not Found, R304.5.1, R304.2.2

Compliance	Description	Data	Compliance	Description	Data
N/A	Ramp Length (in)	43.5	No	Ramp Slope (%)	11.2
No	Ramp Width (in)	45.5	Yes	Ramp XSlope (%)	1.9
N/A	Flare Type LT	N/A	N/A	Flare Type RT	N/A
N/A	Flare Slope LT (%)	N/A	N/A	Flare Slope RT (%)	N/A
N/A	Flare Traversable LT?	N/A	N/A	Flare Traversable RT?	N/A
N/A	Landing Length (in)	N/A	N/A	DWS Provided?	N/A
N/A	Landing Width (in)	N/A	N/A	DWS Contrast?	N/A
N/A	Landing Slope (%)	N/A	N/A	DWS Length (in)	N/A
N/A	Landing X Slope (%)	N/A	N/A	DWS Full Width?	N/A
N/A	Landing Curb? (Y/N)	N/A	N/A	DWS Offset (in)	N/A
N/A	Shared Landing?	N/A			
N/A	Gutter Ponding?	N/A	N/A	Gutter Slope (%)	N/A
N/A	Gutter Lip Ht (in)	N/A	N/A	Gutter X Slope (%)	N/A
N/A	Painted X Walk1?	No	N/A	Painted X Walk2?	No
	X Walk 1 Direction	To S		X Walk 2 Direction	To E
N/A	X Walk 1 Width (in)	N/A	N/A	X Walk 2 Width (in)	N/A
	X Walk 1 Slope (%)	0.5		X Walk 2 Slope (%)	3.4
	X Walk 1 X Slope (%)	1.8		X Walk 2 X Slope (%)	0.6

N/A	Ramp inside XWalk1?	N/A	N/A	Ramp inside XWalk2?	N/A
	Road Slope (%)	0.7	N/A	Clear Space?	N/A
	Road X Slope (%)	2.5	N/A	Clear Space to XWalk (in)	N/A
N/A	Any Obstructions?	N/A	N/A	Storm Grate/Utility Hazard?	N/A
	Obstruction Type			Storm Grate/Utility Type	
		N/A			N/A
		Yes		Surface Condition? (G/P)	Good

Remove & Replace Curb Ramp With Two New Directional Ramps or Equivalent.

Total Cost: \$ 3200.00
