Access Compliance Report Public Rights-of-Way (Curb Ramps)

Intersection ID: 21078 Main Street: ORCHARD LAKE DR **Cross Street: MONROE RD** Location: W Initial Pass/Fail: Fail **Overall Compliance: No Severity Score:** 25 **ADA ID: D54CCEC666FC** Ramp Type: PerpDiag

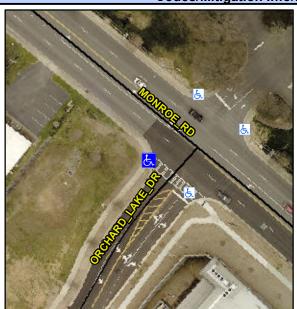
R304.5.3

Compliance Description Data Compliance Description Data Yes N/A Ramp Length (in) 84.0 Ramp Slope (%) 6.6 No Ramp XSlope (%) Yes Ramp Width (in) 59.0 9.5 N/A N/A Flare Type LT N/A Flare Type RT N/A N/A N/A N/A Flare Slope RT (%) N/A Flare Slope LT (%) N/A Flare Traversable LT? N/A N/A Flare Traversable RT? N/A N/A N/A N/A **DWS Provided?** N/A Landing Length (in) N/A Landing Width (in) N/A N/A **DWS Contrast?** N/A N/A N/A N/A Landing Slope (%) DWS Length (in) N/A N/A Landing X Slope (%) N/A N/A DWS Full Width? N/A N/A Landing Curb? (Y/N) N/A N/A DWS Offset (in) N/A N/A N/A Shared Landing? N/A **Gutter Ponding?** N/A N/A Gutter Slope (%) N/A N/A Gutter Lip Ht (in) N/A N/A Gutter X Slope (%) N/A N/A Painted X Walk1? Yes N/A Painted X Walk2? No X Walk 1 Direction To SE X Walk 2 Direction To NE N/A 88.0 N/A X Walk 1 Width (in) X Walk 2 Width (in) N/A X Walk 1 Slope (%) 2.3 X Walk 2 Slope (%) 9.2 X Walk 1 X Slope (%) 7.4 X Walk 2 X Slope (%) 3.6 N/A N/A Ramp inside XWalk2? N/A Ramp inside XWalk1? Yes Road Slope (%) 6.9 N/A Clear Space? N/A N/A Road X Slope (%) 3.5 Clear Space to XWalk (in) N/A N/A N/A N/A Any Obstructions? Storm Grate/Utility Hazard? N/A **Obstruction Type** Storm Grate/Utility Type N/A N/A

Two New Directional Ramps or Equivalent.

Remove & Replace Curb Ramp With
