# Access Compliance Report

## Public Rights-of-Way

### (Curb Ramps)

Intersection ID: 10039534	Main Street: THATCHER_HALL_CT	Cross Street: N/A	Location: SE
ADA ID: D54E5776F774	Ramp Type: BlendTrans1	Initial Pass/Fail: Fail	Overall Compliance: No
Severity Score: 8.75			
Codes/Mitigation Info/Possible Solution		Field Measurements/Component Compliance

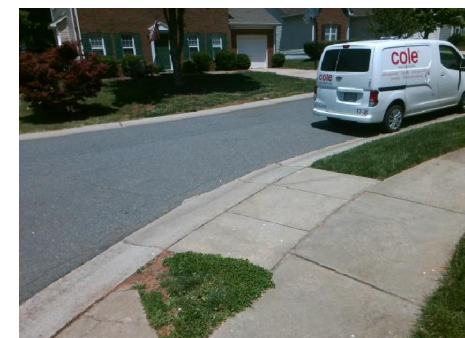
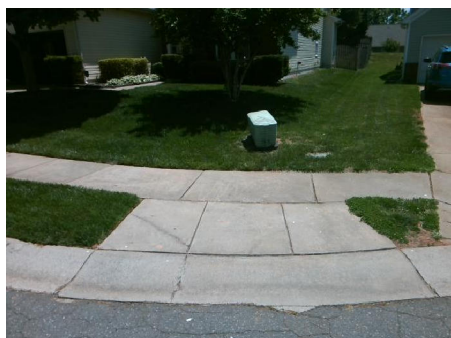
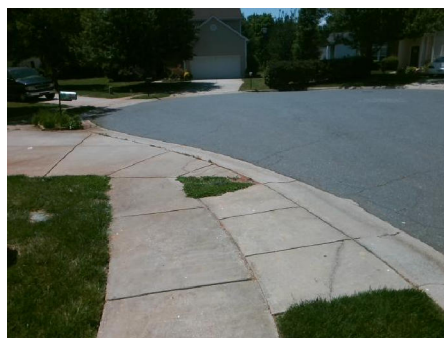
Compliance	Description	Data	Compliance	Description	Data
N/A	Ramp Length (in)	46.0	Yes	BlendTrans Slope (%)	4.9
No	Ramp Width (in)	36.0	Yes	BlendTrans XSlope (%)	1.8
N/A	Flare Type LT	N/A	N/A	Flare Type RT	N/A
N/A	Flare Slope LT (%)	N/A	N/A	Flare Slope RT (%)	N/A
N/A	Flare Traversable LT?	N/A	N/A	Flare Traversable RT?	N/A
N/A	Landing Length (in)	N/A	N/A	DWS Provided?	N/A
N/A	Landing Width (in)	N/A	N/A	DWS Contrast?	N/A
N/A	Landing Slope (%)	N/A	N/A	DWS Length (in)	N/A
N/A	Landing X Slope (%)	N/A	N/A	DWS Full Width?	N/A
N/A	Landing Curb? (Y/N)	N/A	N/A	DWS Offset (in)	N/A
N/A	Shared Landing?	N/A			
N/A	Gutter Ponding?	N/A	N/A	Gutter Slope (%)	N/A
N/A	Gutter Lip Ht (in)	N/A	N/A	Gutter X Slope (%)	N/A
N/A	Painted X Walk1?	No	N/A	Painted X Walk2?	N/A
	X Walk 1 Direction	To N		X Walk 2 Direction	N/A
	X Walk 1 Width (in)	N/A		X Walk 2 Width (in)	N/A
	X Walk 1 Slope (%)	2.6		X Walk 2 Slope (%)	N/A
	X Walk 1 X Slope (%)	3.9		X Walk 2 X Slope (%)	N/A

N/A	Ramp inside XWalk1?	N/A	N/A	Ramp inside XWalk2?	N/A
	Road Slope (%)	3.9		Clear Space?	N/A
	Road X Slope (%)	2.6	N/A	Clear Space to XWalk (in)	N/A
N/A	Any Obstructions?	N/A	N/A	Storm Grate/Utility Hazard?	N/A
	Obstruction Type			Storm Grate/Utility Type	
		N/A			N/A
			Yes	Surface Condition? (G/P)	Good
			No	Curb Slope (%)	7.6

**Remove & Replace Curb Ramp With Two New Directional Ramps or Equivalent.**

**Not Found, R304.5.1**
